**A SURVEY OF HABITAT CONDITION FOR THE FRESHWATER PEARL MUSSEL
MARGARITIFERA MARGARITIFERA
IN THE RIVER SLANEY AT ENNISCORTHY, COUNTY WEXFORD**

DR EVELYN A. MOORKENS

November 2016

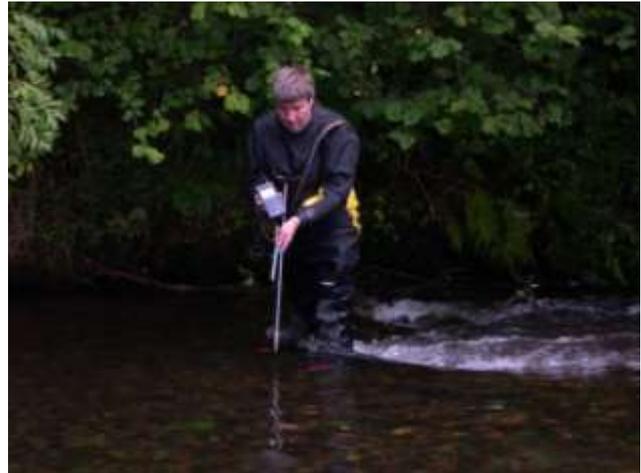
Figure 1 Using a redox meter

2.3 The Redox equipment comprises a 0.7m long probe fitted with a platinum tipped electrode, a reference Ag/AgCl electrode and a meter with a millivolt display. A reading is obtained by holding both electrodes in the water column until a stable reading is obtained (typically this would be 450-580mV). With the Ag/AgCl electrode remaining in the water column, the platinum electrode is then inserted into a depth of 5cm in the substrate and a reading taken immediately.

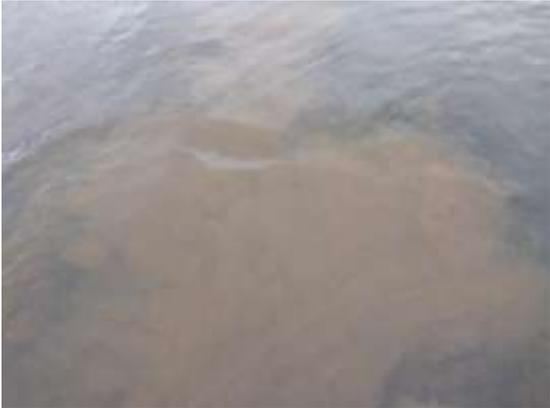
The visual assessment was based on 15 parameters as noted in Table 2. There was considerable difference in quality between the poorer downstream area and the area upstream of the island, which had some conditions suitable for adult and juvenile mussel survival. Photography was difficult due to the depth and poor light (Table 3).

<p>Very silted substrate downstream of island</p>	<p>Dark conditions prevented photography in deeper areas</p>

- a) By safeguarding the habitat areas with good juvenile potential upstream of the island
- b) By translocating the downstream mussels that would be negatively affected by dredging to the vicinity of Scarawalsh Bridge, if an appropriate licence was issued to do so.
- c) Any translocation receptor sites would need to be chosen and carefully documented using the methodology of Killeen & Moorkens (In press), including clear labelling of each mussel.
- d) A monitoring programme to include 6 month, 1 year and annual monitoring thereafter for 5 years would be needed to include habitat assessment, stress testing and a recommendation for removal if the receptor site is found to be or becomes unsuitable.
- e) A monitoring programme for the habitat area upstream of the island to assess its quality over time after the proposed flood defence works are undertaken.

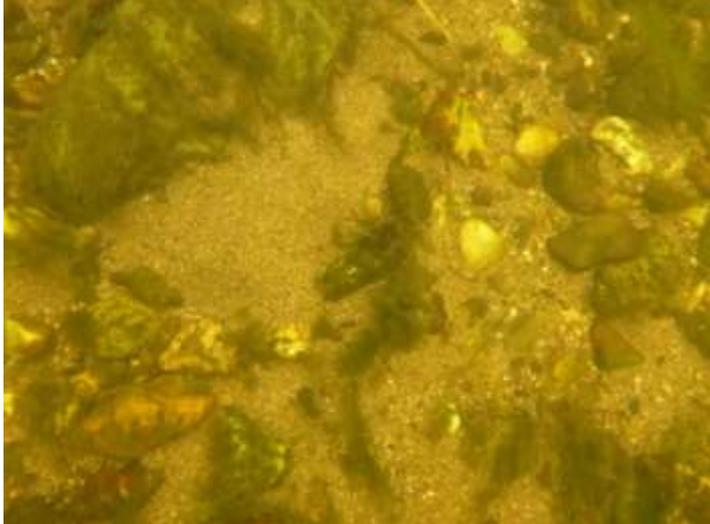
<p>Good juvenile habitat with adult mussel in clean gravel in the lee of boulder upstream of the island</p>	<p>Looking downstream towards island from area of good mussel habitat</p>

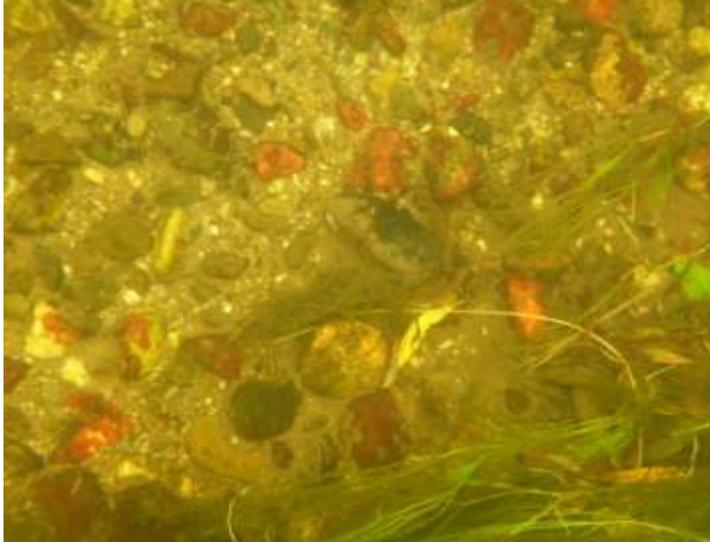
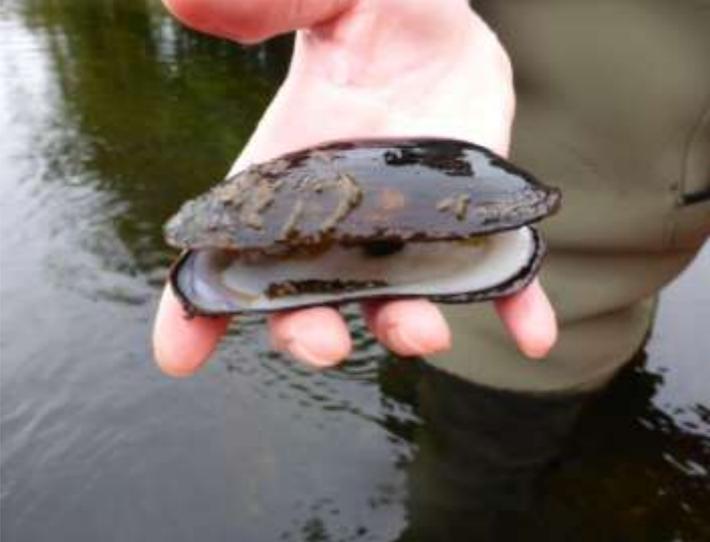
<p>Recently dead shell on river bed in Area 2</p>	<p>Dead mussel still had flesh inside and had no scar marks</p>

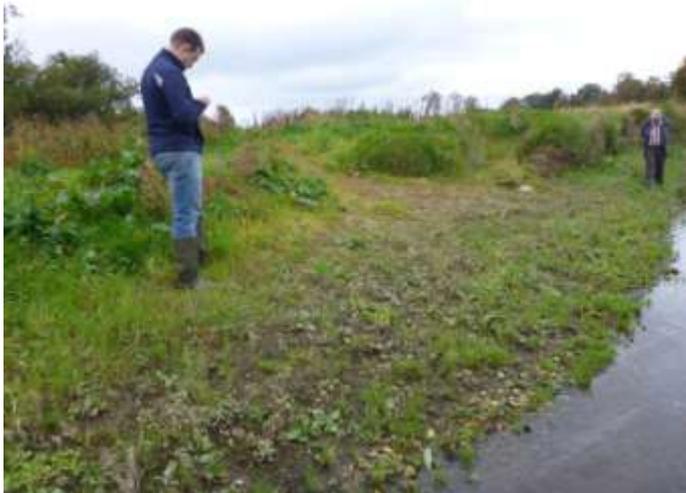
The side channel on the left bank was walked from its entry area to its return to the Slaney. The inflow area may be considered for reprofiling. The main channel here was highly silted toward the edge, but *Anodonta anatina* was seen and some shell fragments of both *Margaritifera* and *Anodonta* were found on the bank. The small channel entry was not connected at the time of the survey, and is likely to only be connected during high flow, providing a stable ponded habitat outside of high flow times. There is consequently some good wetland and transitional habitat present, as well as a valuable tree line, well used by birds during the visit. A flock of long-tailed tits were making their way up the tree line, demonstrating its value as a corridor to and from the town.

<p>Current bank rising from the Slaney above which flooding has to occur to reach the side channel</p>	<p>Overgrown side channel close to the north end</p>

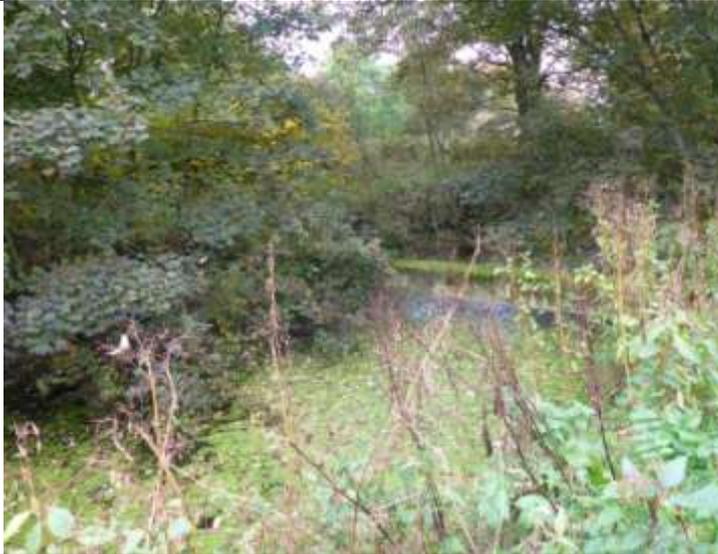
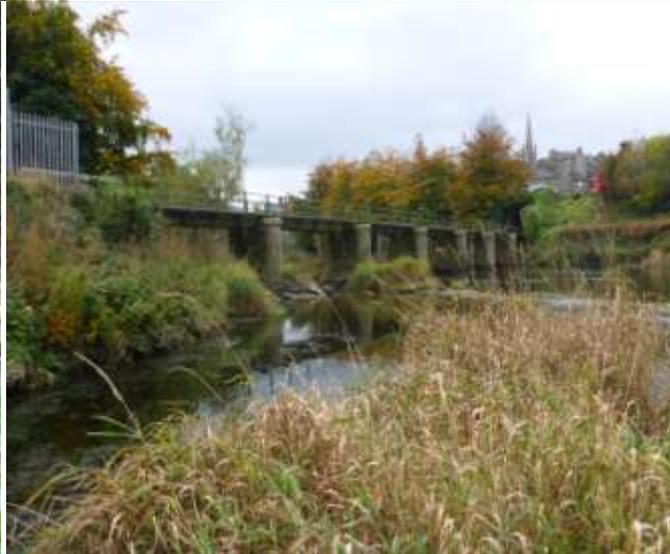
<p>Standing water with <i>Lemna</i> further downstream in channel</p>	<p>Wider area of standing water at southern end of channel</p>
