Enniscorthy Flood Defence Scheme Aquatic Ecology Survey

Version (15th March 2018)

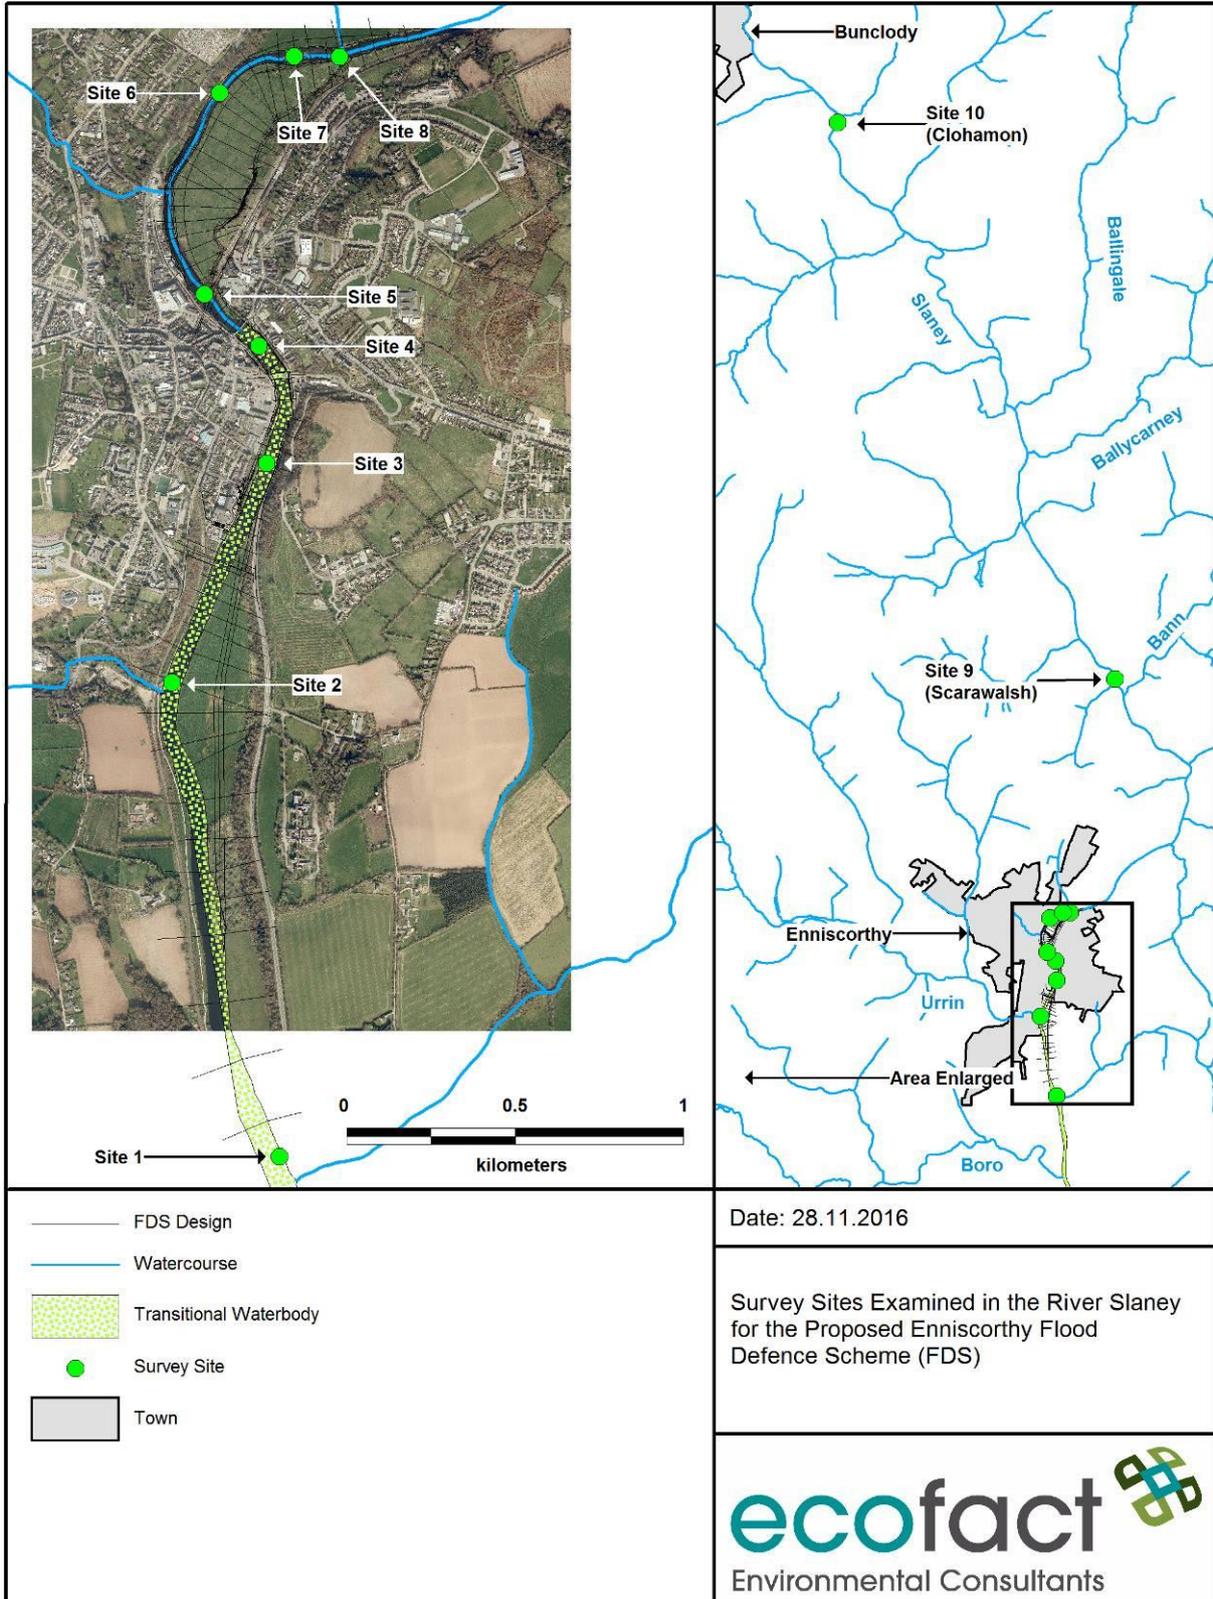
Figure 3: Aquatic ecology survey sites examined in the River Slaney for the proposed flood defence scheme.

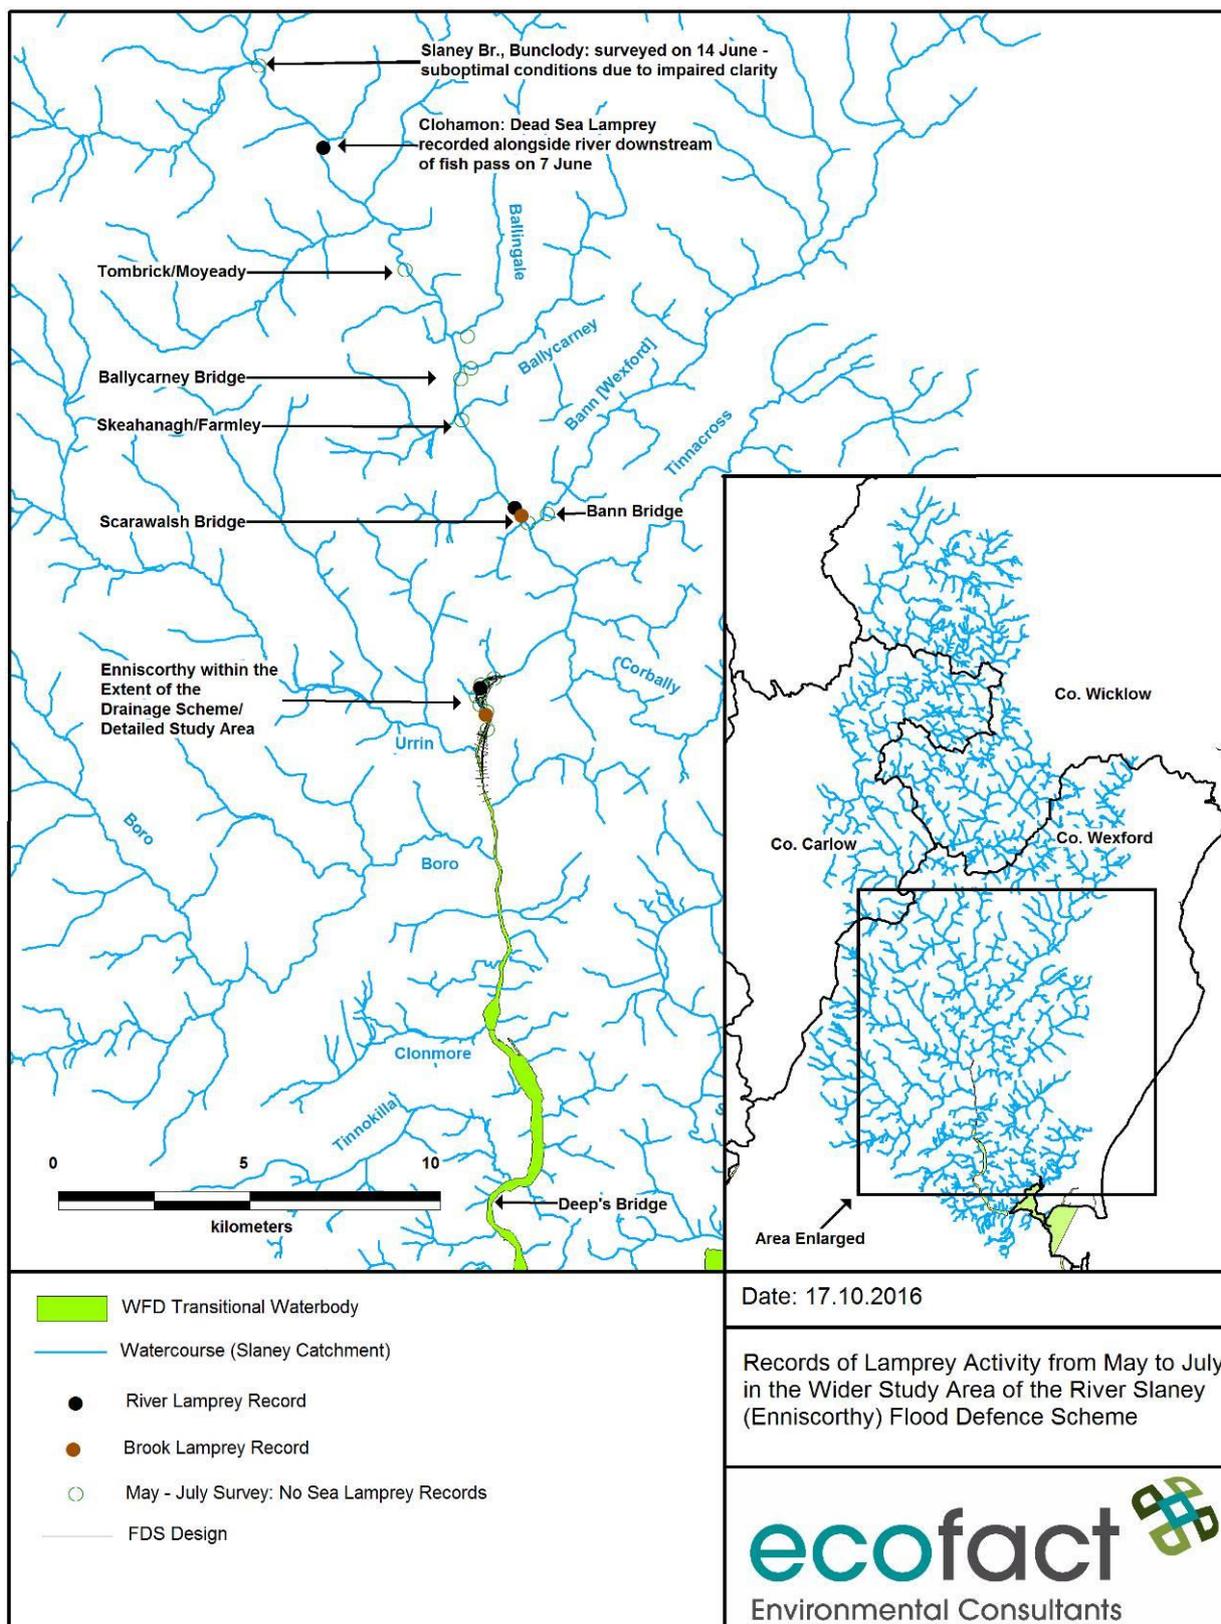
Figure 5: Records of Lamprey activity from May to July in the wider study area of the River Slaney (Enniscorthy) Flood Defence Scheme.

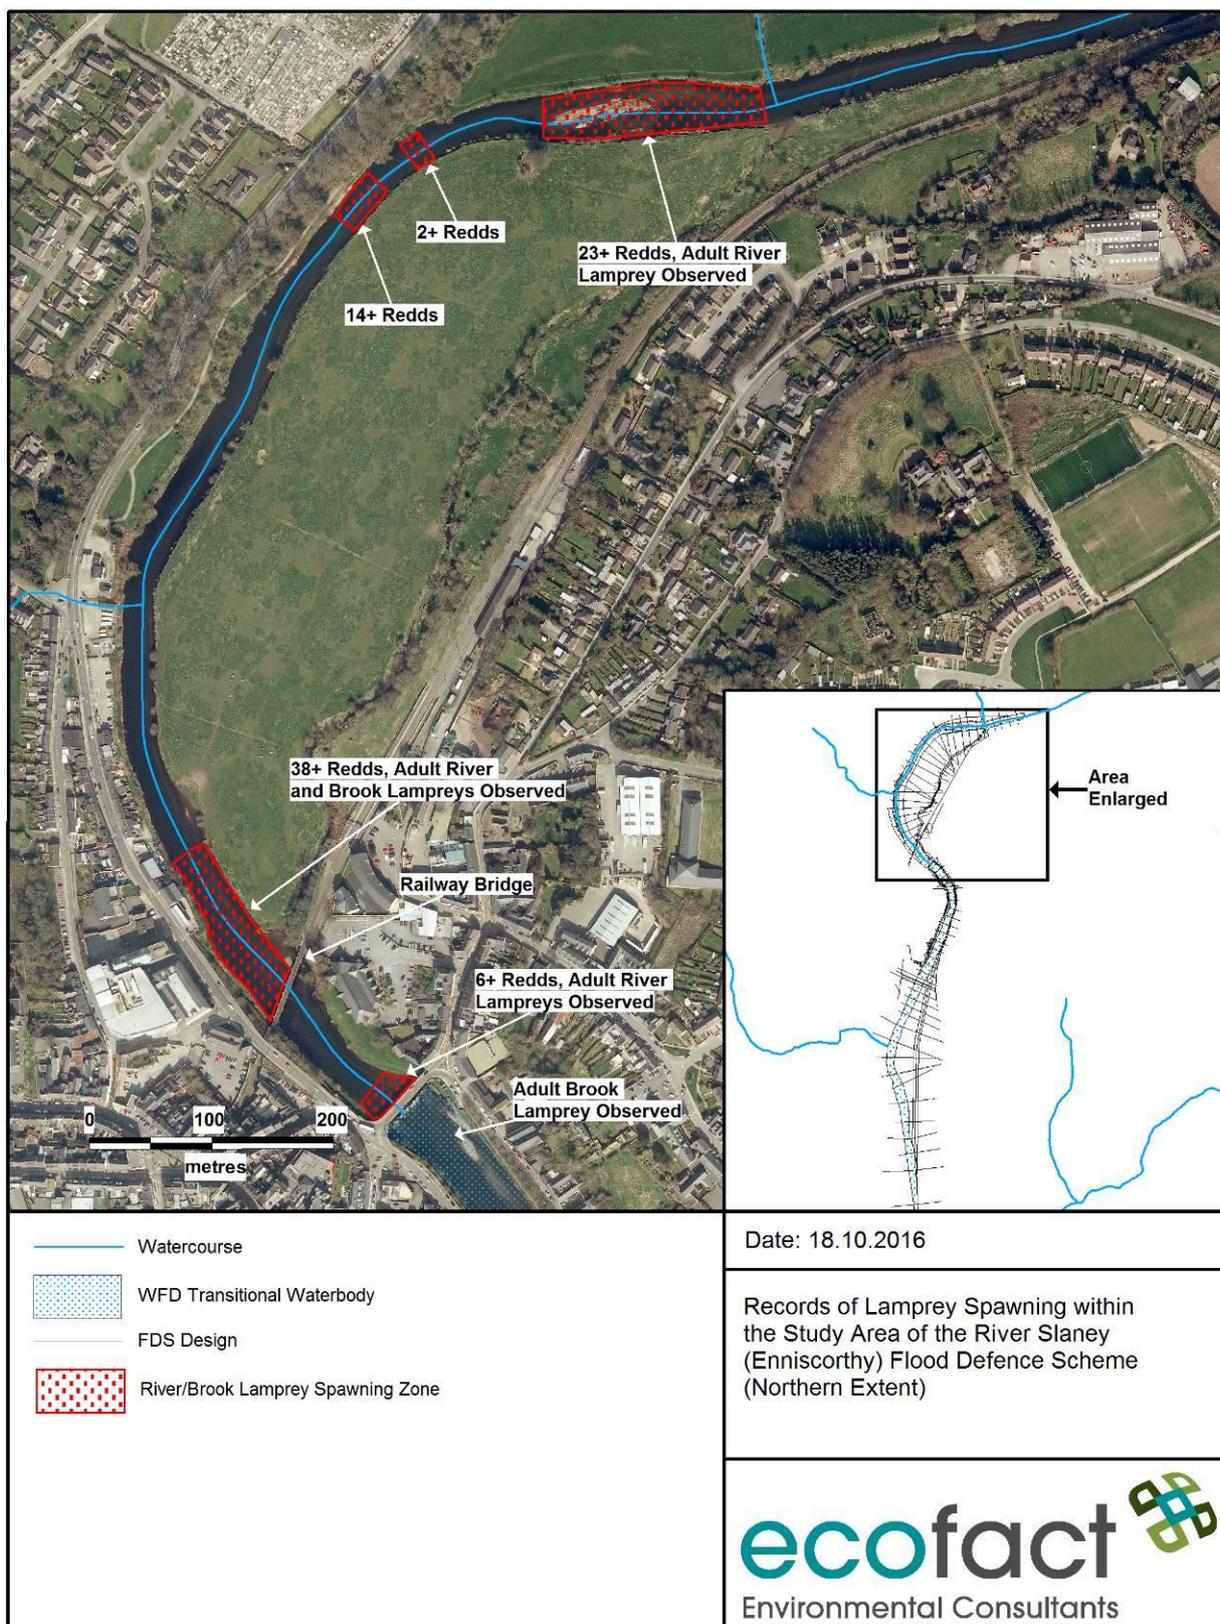
Figure 6: Records of lamprey spawning within the study area of the River Slaney (Enniscorthy) Flood Defence Scheme.

A stretch of the river approximately 800m upstream of the Railway Bridge was also found to be used as a spawning area, as evident by pockets of disturbed gravels. It is believed that most spawning in this area took place at an earlier stage with regard to the spawning downstream, as silt had already started to accumulate on some redds in this area. This part of the river was deeper and flows were faster during previous visits. Conditions at this earlier time were probably more suited to lamprey spawning but were not detected then. Three clusters of redds were recorded in this part of the river, at S97383 40628 (10+ redds), S97400 40648 (4 redds) and at S97434 40681 (2 redds).

Another lamprey spawning area was identified around the island within the river where flows are relatively high and depths are shallow. Two redds were recorded downstream of the island at S97551 40710 and a single redd at S97579 40704. The main area of spawning activity in this part of the river was at the end of the pool upstream of the island where approximately 25 redds were recorded. Some disturbances here could possibly have been caused by anglers however. At Scarawalsh, at least 10 redds most likely to have been those of River Lamprey were recorded at the end of the pool immediately downstream of the bridge. Three River Lampreys were recorded at one of these redds. Redds were not recorded in the River Slaney at Ballycarney, Moyeady/Tombrick (large pool) and Clohamon despite extensive searches being carried out.

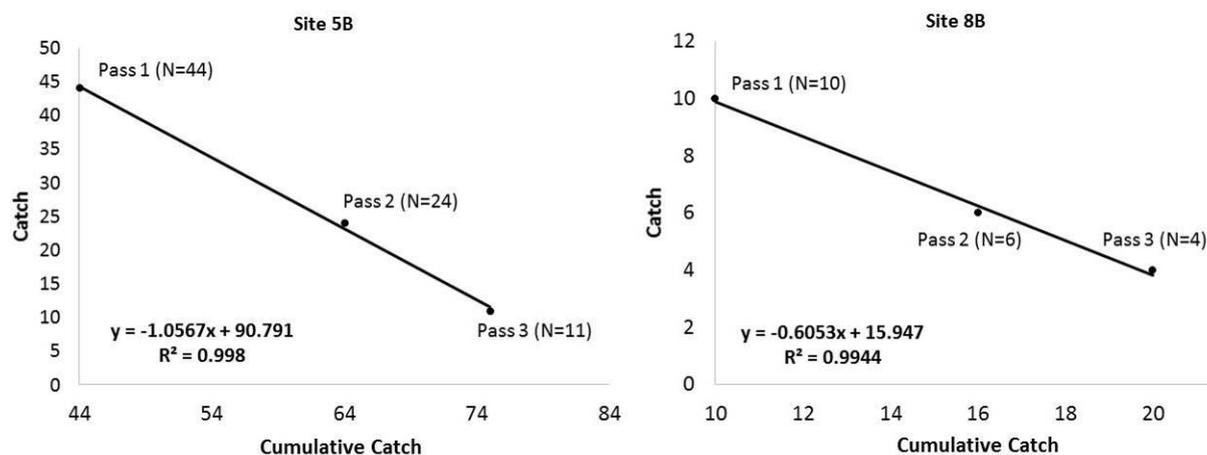
Figure 7: Depletion lines, Leslie-Davies method, for the numbers of lampreys captured during the quantitative electrical fishing investigations on the River Slaney (Site 5B and Site 8B).

Table 10: Results of the depletion electrical fishing surveys at subsite 5B and 8B and population estimate/m².

5B	8B
Pass 1	44	10
Pass 2	24	6
Pass 3	11	4
Total	75	20
Population estimate (lampreys/m ²)	86	26

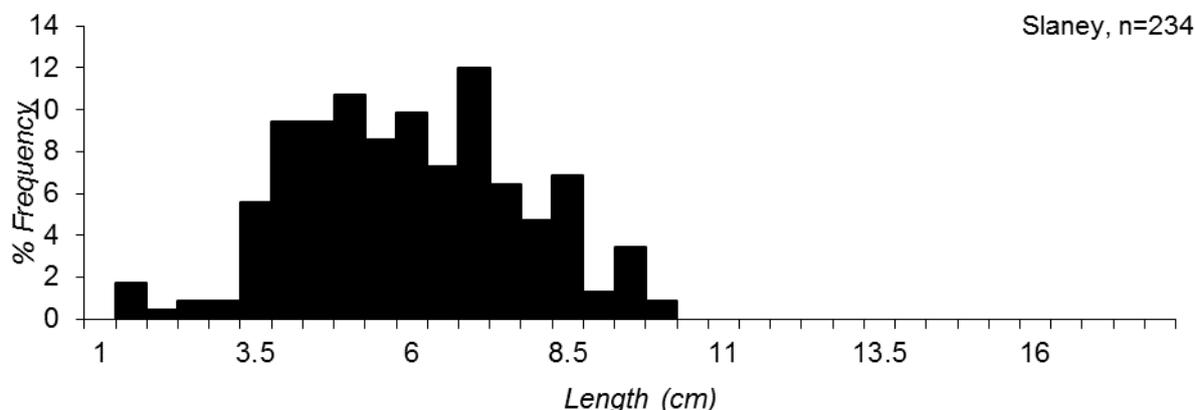
Figure 8: Length (cm) percentage frequency distribution of 234 River/Brook Lamprey ammocoetes from the July 2016 survey. This is a typical size distribution of a *Lampetra fluviatilis* dominated population which metamorphose earlier (and smaller) and migrate to the sea/estuary to feed.

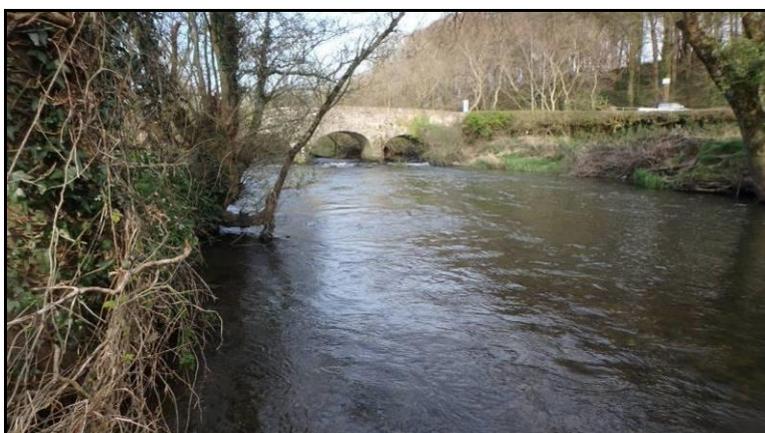
Plate 11: River Bann downstream of Bann Bridge approximately 250m upstream of the Slaney River. Flow and substrate conditions at the end of this pool provide an ideal spawning habitat for lampreys and salmonids.

The River Bann was surveyed from Bann Bridge (approximately 250m upstream of the Slaney River) to the River Slaney. Flow and substrate conditions at the end of the pool immediately downstream of Bann Bridge provide an ideal spawning habitat for lampreys and salmonids but no evidence of spawning was recorded here or elsewhere in the River Bann in the surveys carried out to date.

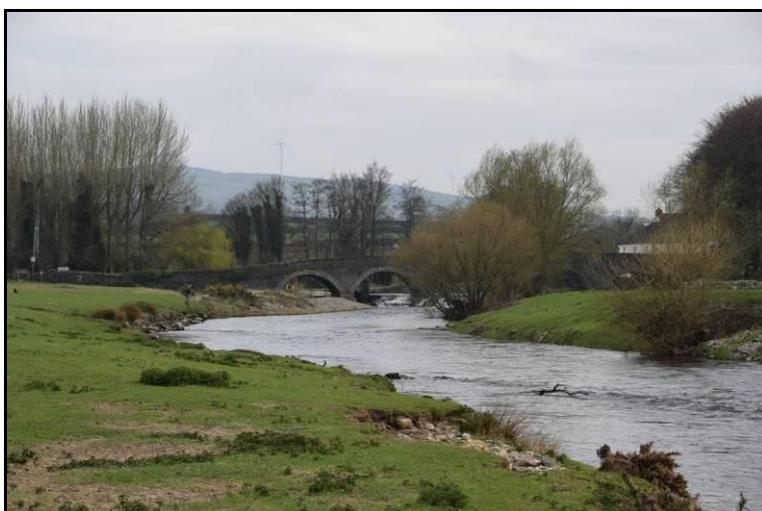
Plate 14: Stretch of the Slaney downstream of Clohamon Weir. This stretch of the river is depleted due to the operation of a small hydroelectric scheme at the left side of the channel.

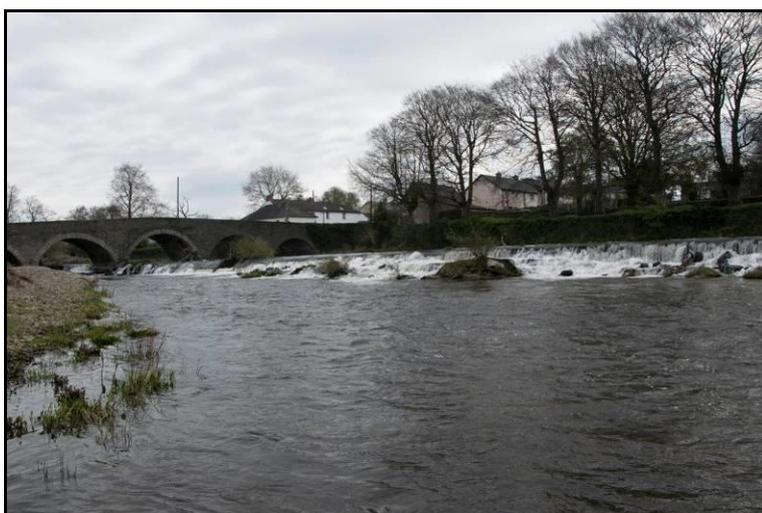
Plate 15: Clohamon Weir is considered an obstacle for migrating lampreys. A Grey Heron was seen under the bridge on 14th April and was deemed to have been preying on River Lampreys.

No lamprey spawning activity was observed or evidence of same recorded during the surveys carried out on the 14th and 15th April. Both the bridge at Ballycarney and Clohamon Weir were considered obstacles for upstream migrating lampreys. A Grey Heron was seen under the bridge at Clohamon on 14th April and was deemed to have been preying on River Lampreys. Indeed, a River Lamprey was found under the bridge thereafter and was probably removed from the river by the Heron which dropped its quarry upon being disturbed. This conclusion was based on the fact that the lamprey was still alive. The observation of a River Lamprey at Clohamon indicates that this species is able to negotiate the fast waters at bridges downstream, namely those at Scarawalsh and Ballycarney. Based on the mid April visit, it was obvious that River Lampreys were present in the river but had not started spawning.

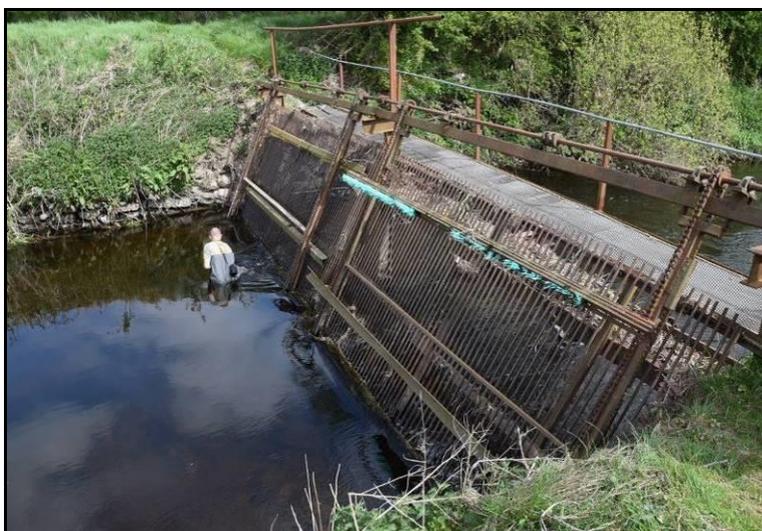
Plate 17: Surveying Clohamon hydro tailrace screen, June 2016. Lampreys and salmonids are entering here and getting trapped below hydro scheme in significant numbers.

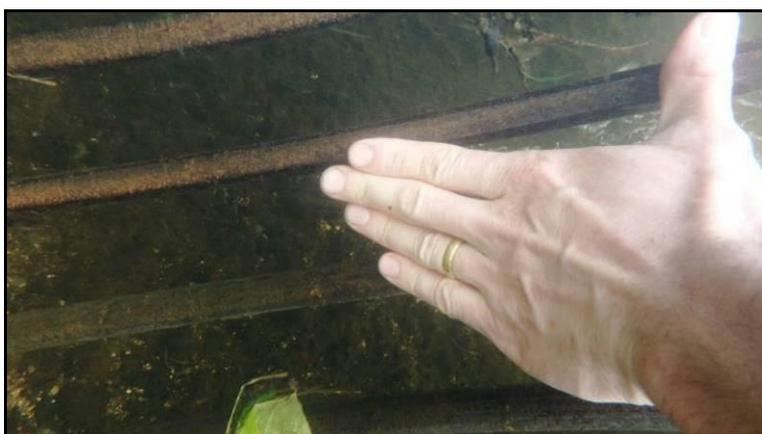
Plate 18: The spacing between the bars on the Clohamon hydro-scheme tailrace fish screen are in the order of 35mm. It is considered that River Lampreys could easily swim through this screen.

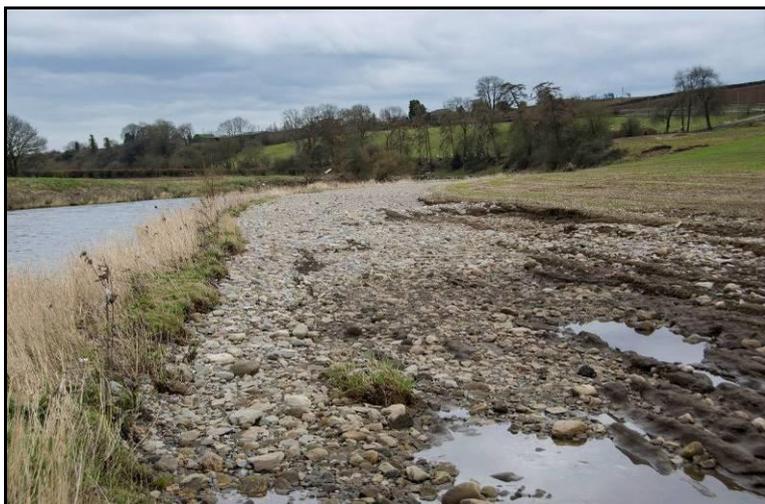
Plate 21: There is a lack of a protective riparian area along much of the River Slaney. The impact of flooding in a field downstream of Clohamon is obvious here, where soil has been lost to the river and will continue to be eroded.

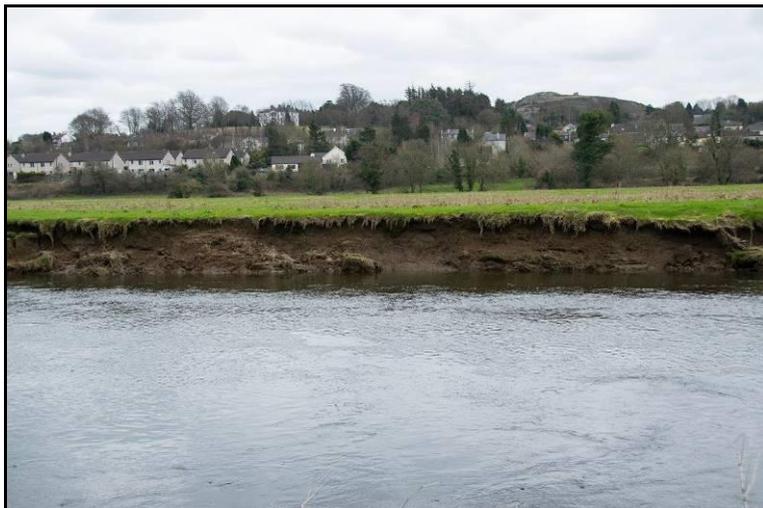
Plate 22: Bank slippage is an undesirable feature along the left bank of the River Slaney in the stretch upstream of Enniscorthy town.

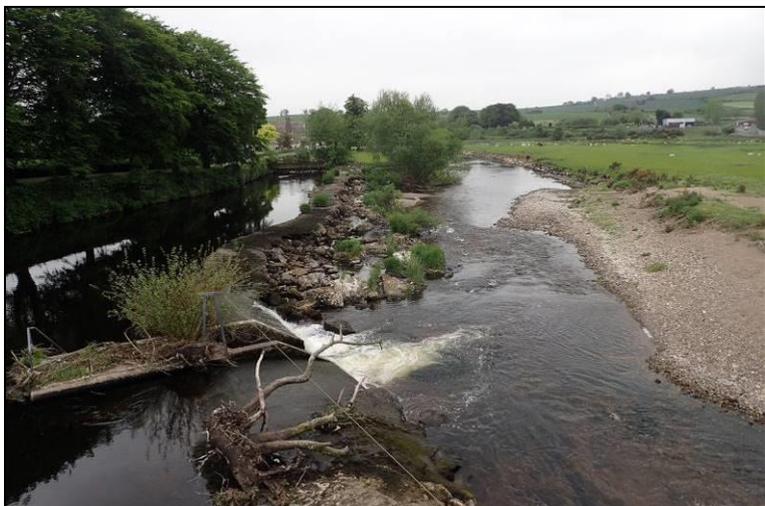
Plate 47: Clohamon weir on the 26th May 2016. This is a major fish migration barrier.

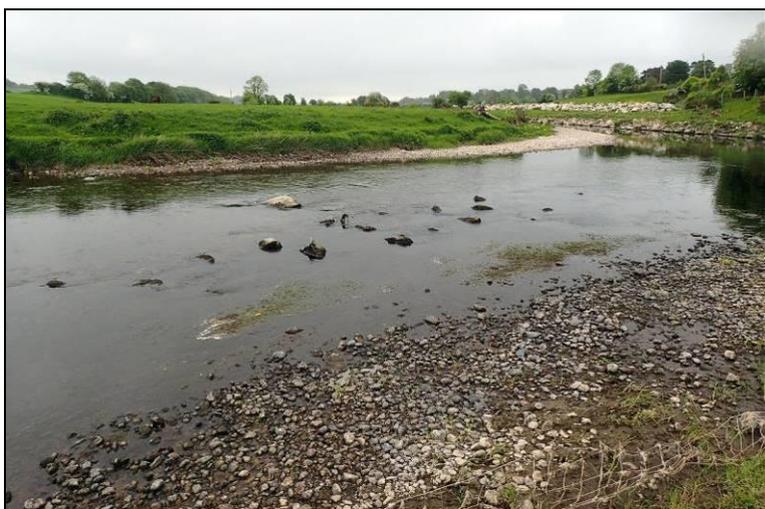
Plate 48: Residual channel of the River Slaney at Clohamon, 26th May 2016. Too much water was being taken into the hydroelectric scheme on this day.

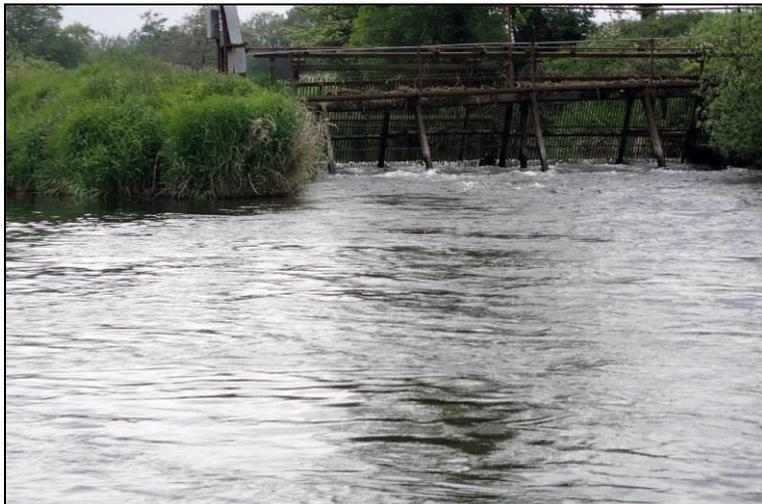
Plate 49: Tailrace screen of Clohamon hydroelectric scheme on the 26th May 2016. Adult lampreys are likely to enter the tailrace here in significant numbers.
