Enniscorthy Flood Defence Scheme Aquatic Ecology Survey

Version (15th March 2018)

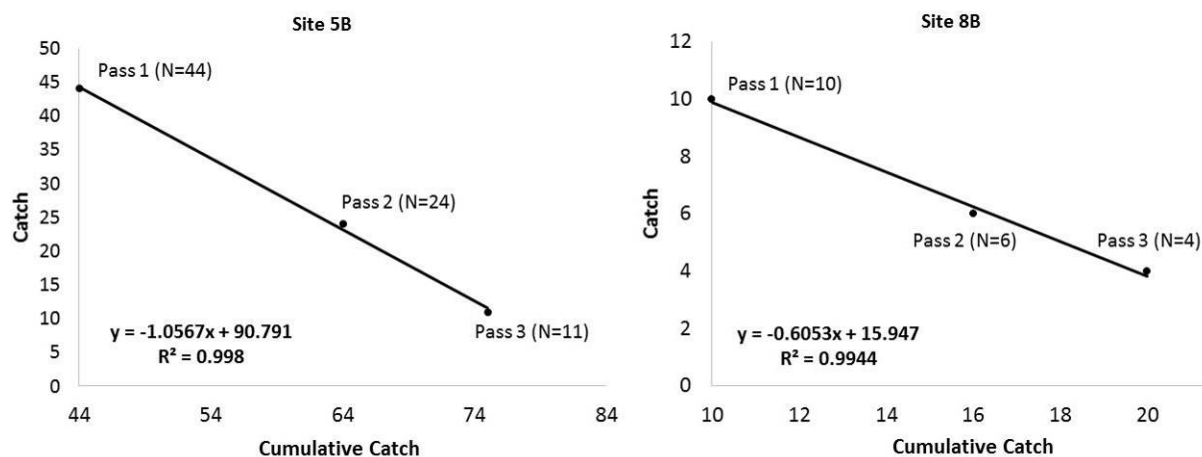
Figure 7: Depletion lines, Leslie-Davies method, for the numbers of lampreys captured during the quantitative electrical fishing investigations on the River Slaney (Site 5B and Site 8B).

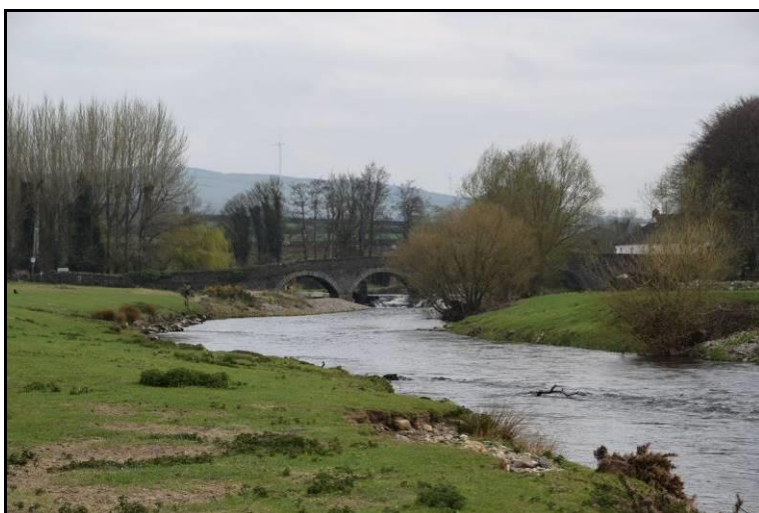
Plate 14: Stretch of the Slaney downstream of Clohamon Weir. This stretch of the river is depleted due to the operation of a small hydroelectric scheme at the left side of the channel.

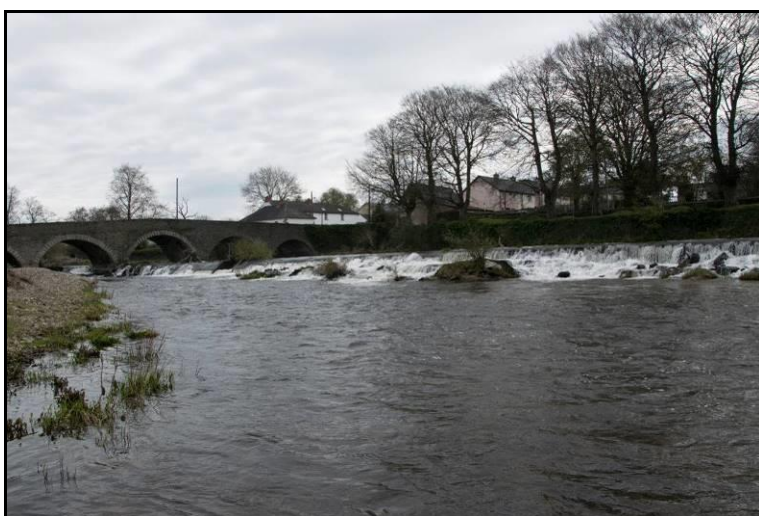
Plate 15: Clohamon Weir is considered an obstacle for migrating lampreys. A Grey Heron was seen under the bridge on 14th April and was deemed to have been preying on River Lampreys.

It is not known how River lampreys pass Clohamon weir and it is clear that this is still a major fish migration barrier. One possible mechanism by which River Lampreys could pass this weir would be if the weir was flooded out as this would potentially provide a pathway along the right bank under the normally dry arch by which River Lampreys could possibly pass upstream. However, such conditions were not observed during the current survey and it is likely that such a passage opportunity at this weir may not always occur. Another mechanism would be that the lampreys find small leaks and holes in the weir and pass upstream through these. This issue was discussed with Dr. Jimmy King of Inland Fisheries Ireland in January 2017 and it is accepted that at least some River Lampreys can pass Clohamon weir. It is concluded that migratory River Lampreys could potentially pass Clohamon weir if flood conditions flooded the dry arch of the bridge during a period when River Lampreys were migrating. However, it must also be concluded that such conditions would not always occur and coincide with lamprey migration (e.g. winter 2016/2017). The weir does have a number of leaking crevices and some lamprey may perhaps use these to pass upstream. However this has not been observed. During normal flow conditions Clohamon weir is generally an impassable barrier to the movements of all three-lamprey species. Moreover, the barrier in the tailrace of this scheme would not stop lampreys entering. It is almost certain that significant numbers of migrating lampreys enter here and run up the tailrace only to get trapped below the turbines. It is noted that adult Salmon and Sea Trout also enter this tailrace – a significant rescue operation involving several hundred salmon and sea trout had to be undertaken in 2016 by IFI staff (Alan Cullagh pers. Comm.). A single Twait shad was also found during this operation.

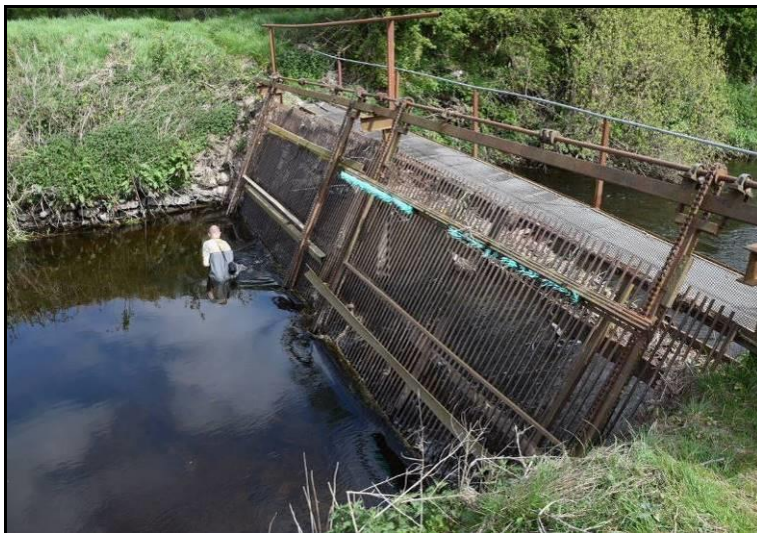
Plate 17: Surveying Clohamon hydro tailrace screen, June 2016. Lampreys and salmonids are entering here and getting trapped below hydro scheme in significant numbers.

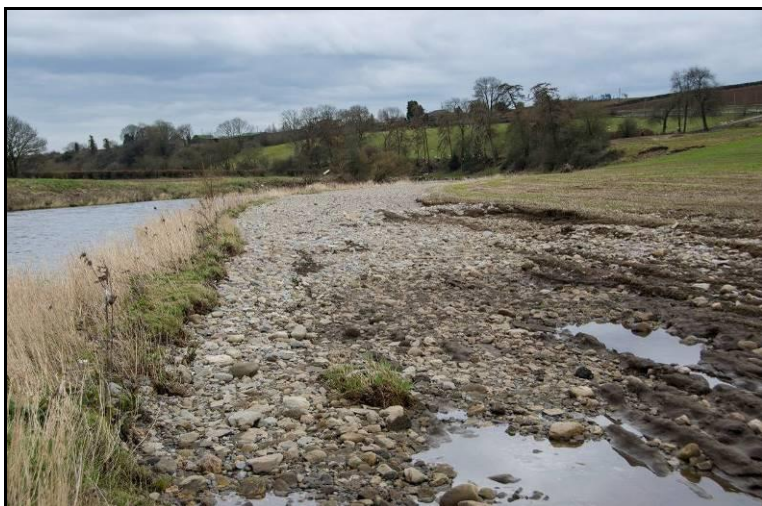
Plate 21: There is a lack of a protective riparian area along much of the River Slaney. The impact of flooding in a field downstream of Clohamon is obvious here, where soil has been lost to the river and will continue to be eroded.

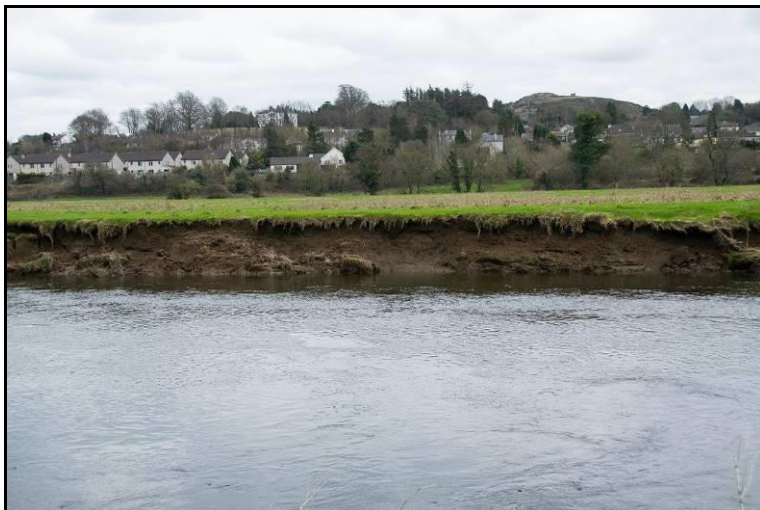
Plate 22: Bank slippage is an undesirable feature along the left bank of the River Slaney in the stretch upstream of Enniscorthy town.

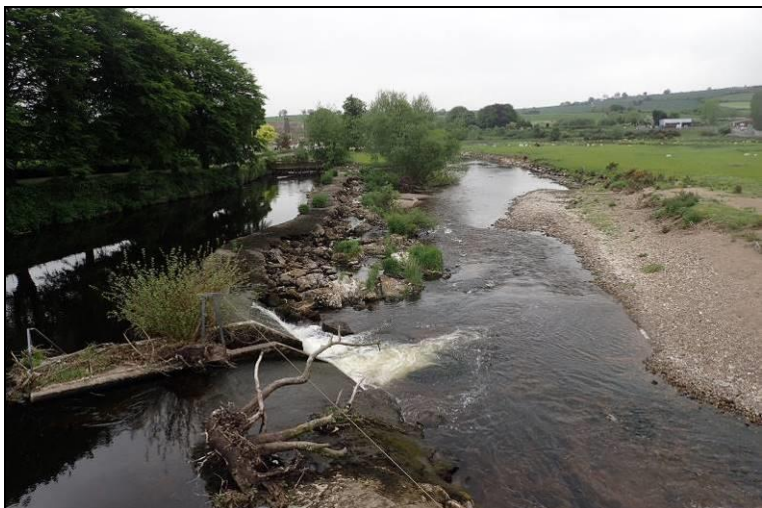
Plate 47: Clohamon weir on the 26th May 2016. This is a major fish migration barrier.

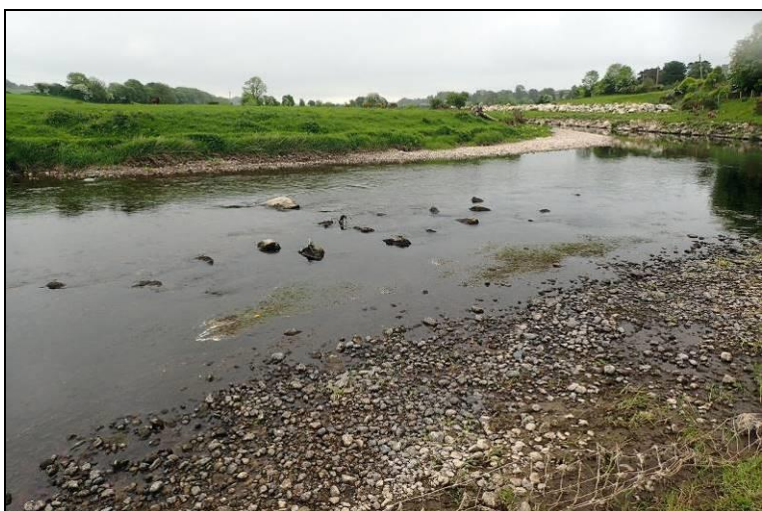
Plate 48: Residual channel of the River Slaney at Clohamon, 26th May 2016. Too much water was being taken into the hydroelectric scheme on this day.

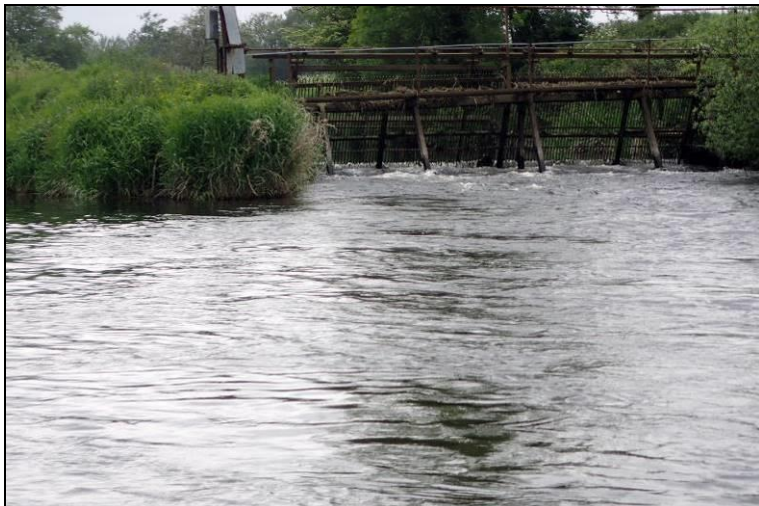
Plate 49: Tailrace screen of Clohamon hydroelectric scheme on the 26th May 2016. Adult lampreys are likely to enter the tailrace here in significant numbers.
