An assessment of hydrological, hydrogeological and geomorphological conditions for the freshwater pearl mussel *Margaritifera margaritifera* for the potential translocation of mussels from Enniscorthy

Part 1 High Flow Survey

DR EVELYN A. MOORKENS

February 2018

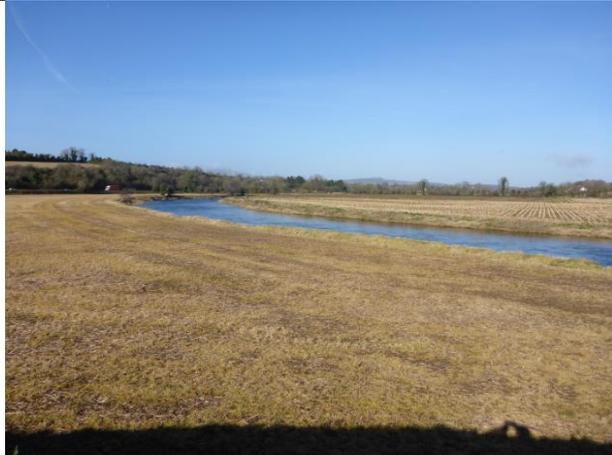
a

<p>1. Upstream of Scarawalsh Bridge</p> <p>Upstream of the bridge, the river is fast flowing and uniform, with intensive riparian management to the banks at either side (a, b).</p> <p>Unsuitable for juvenile mussels.</p> <p>All 6 eyes of Scarawalsh Bridge were flowing on the day of the survey (c).</p>

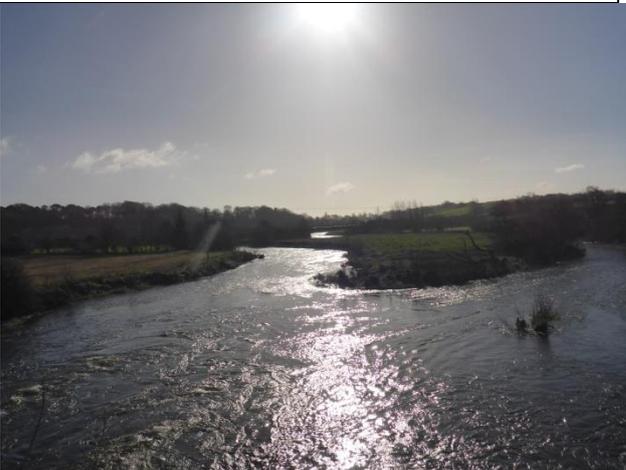
<p data-bbox="252 1122 722 1189">2. Downstream of Scarawalsh Bridge, upstream of Island</p> <p data-bbox="204 1227 751 1335">The pull of flow in the area upstream of the island is quite strong but with potential to be protected from scour in the winter flows.</p> <p data-bbox="204 1368 691 1402">This area merits low flow investigations.</p>	<p data-bbox="810 1081 826 1113">c</p>

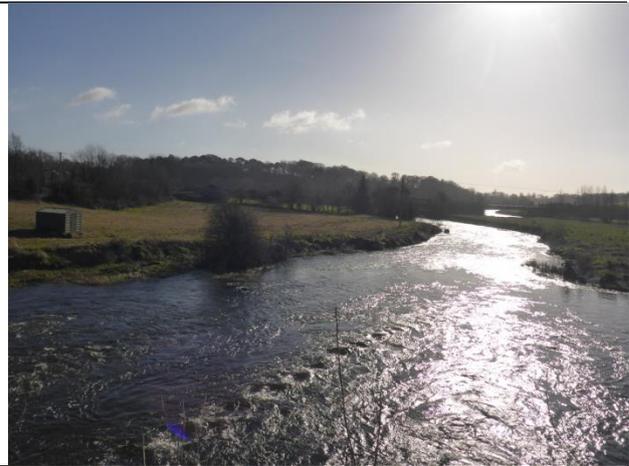
a

The left branch appears to have higher flow than the right branch, and thus may carry the main river discharge, and thus preferential flows suitable for *Margaritifera*. Both the island banks and the land river banks are low enough to support flooding and thus prevent mussels from scouring out of their habitat (a).

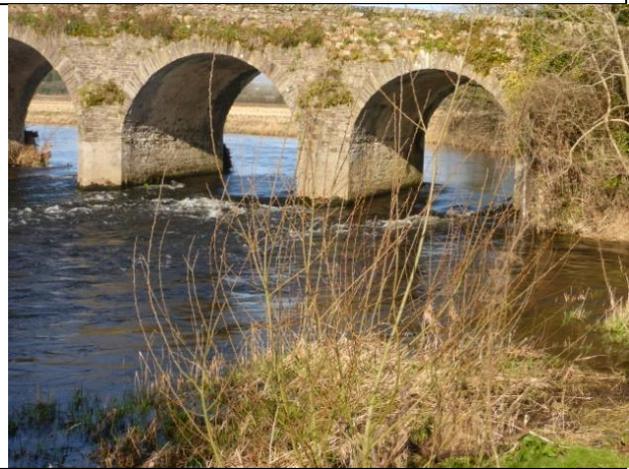
b

An eroded area just downstream of the bridge in the vicinity of the gauge is unsuitable habitat (b). Dense weed is visible under and at the surface in this area (c).

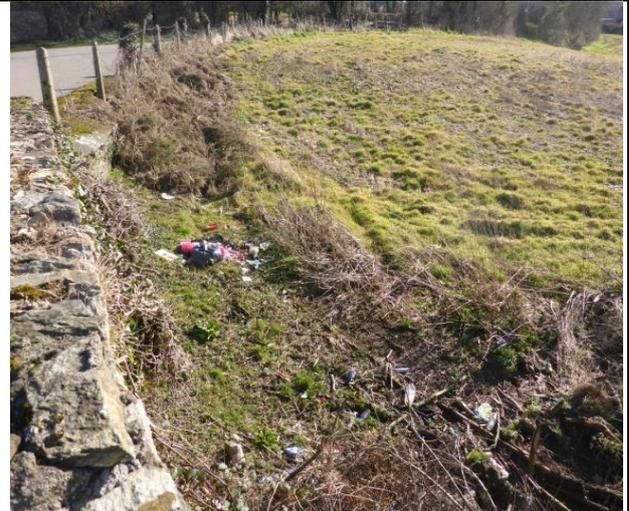
There was rubbish accumulating in the field from where it has been thrown from the bridge (a). A local walker told us this was a constant problem, and there had been everything from household rubbish to a car dumped in this field. This is a source of concern.

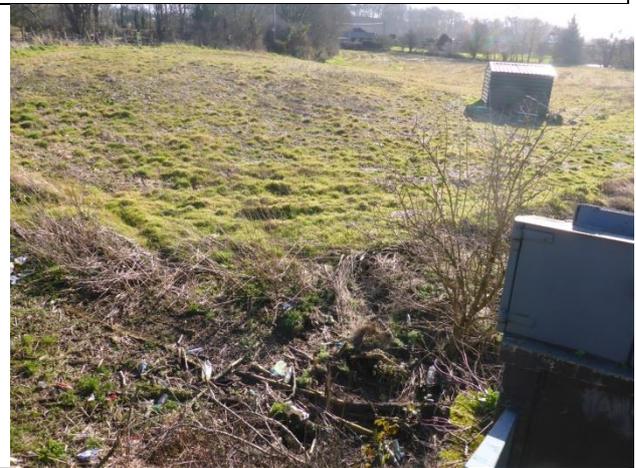
b

The winter debris line demonstrates that the river retains the ability to flood into this field, which is a positive indication that flows are suitable and not scouring (b).

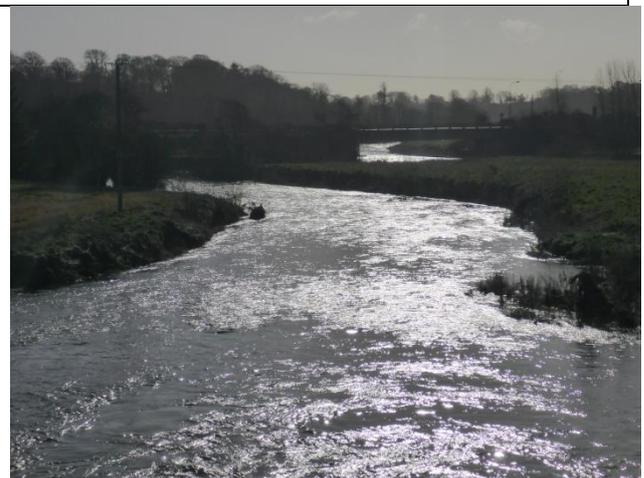
a

4. Further downstream along left channel (a)

Depending on the preferential flows during low flow periods, this area may have potential habitat.

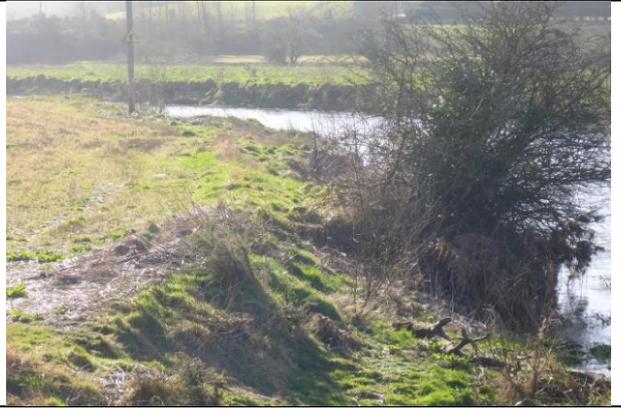
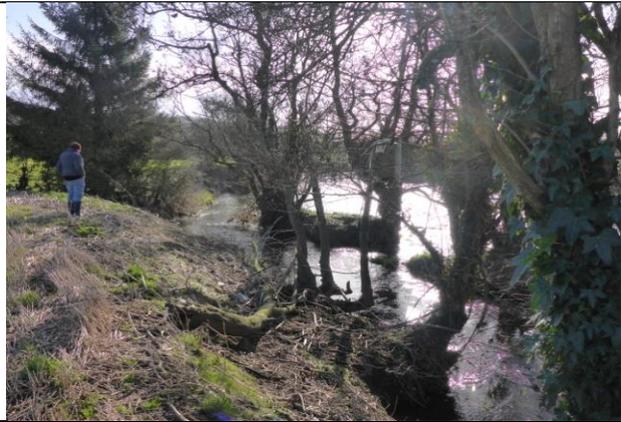
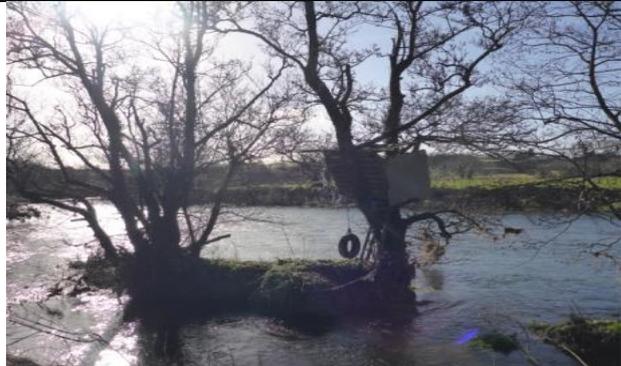
There has been some erosion in the past with two-tier bank heights and isolated island areas that were once part of the main left bank (b-d).

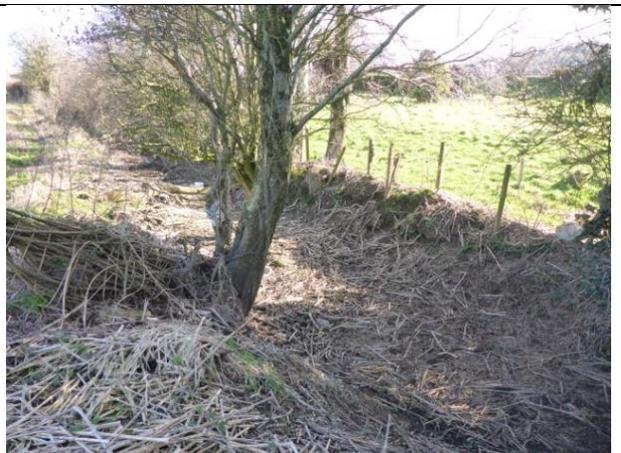
5. Dry drain entering river at S 98410 44945

This ditch would be likely to be a source of fine sediment when running wet, although this may not happen very often. It is unlikely that there will be good habitat found downstream of this point in the left hand channel.

The instream low flow survey should concentrate on the area from Scarawalsh bridge to the dry ditch entry into the left limb and the stream entry into the right limb.

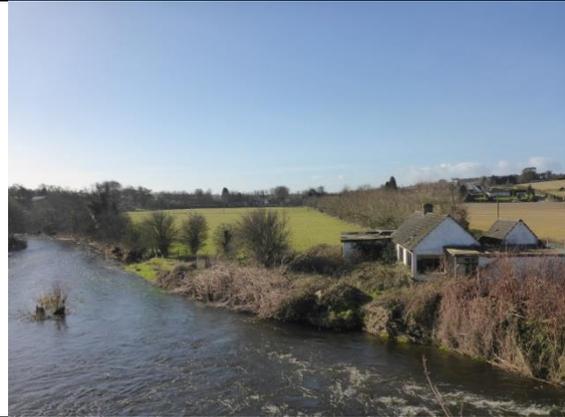
a

Vegetated, relatively high banks are present between the old house and the river just downstream of the bridge (a).

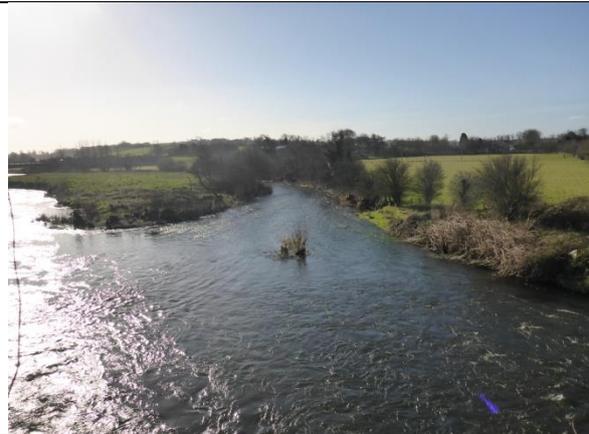
b

The flow is straight and rather shallow towards the channel to the right of the island (b).

Probably unsuitable as habitat in this area.

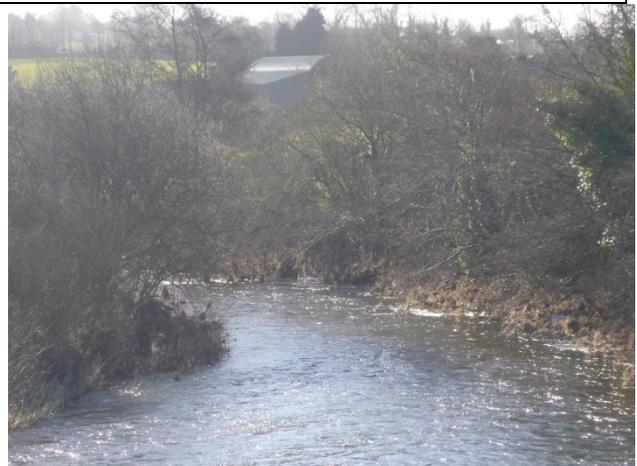
The right hand limb appears to have the minor flow and although it looks suitable at high flow, it needs to be checked for potential at low flows.

There are trees growing on both the land and the island banks for most of the length of this limb.

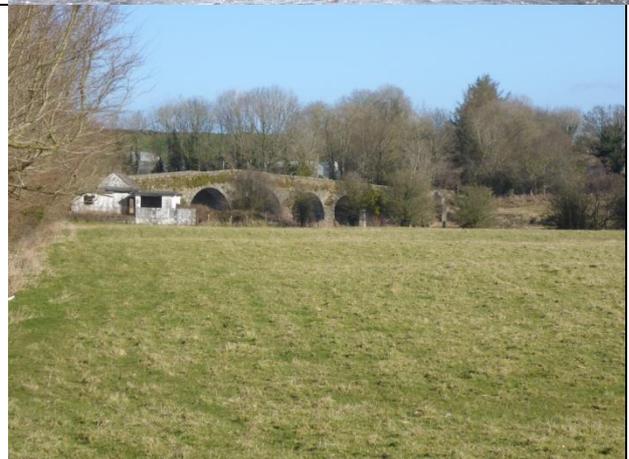
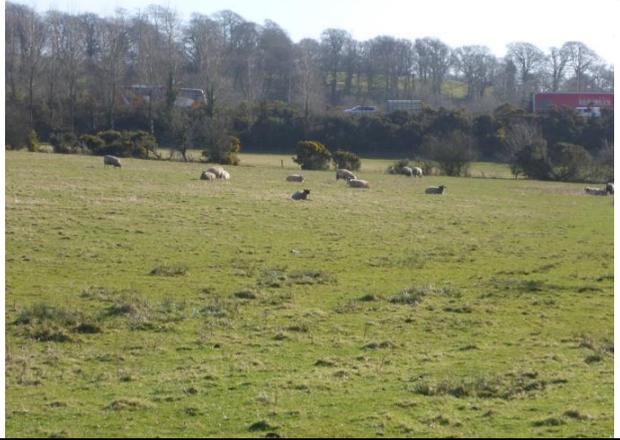
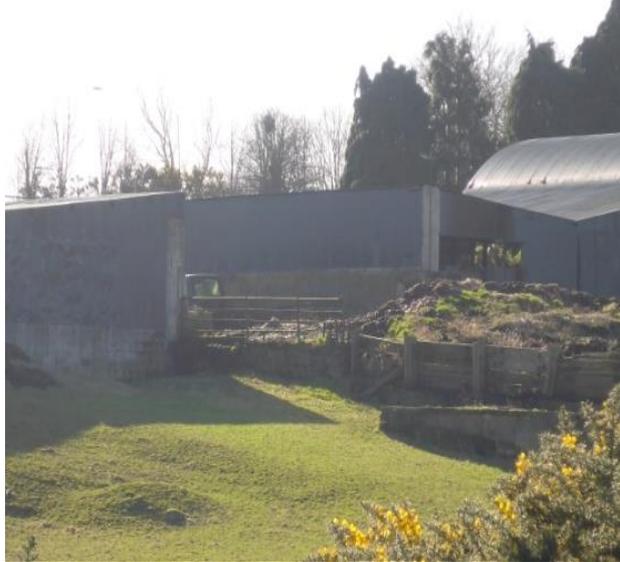
There is rather intensive sheep grazing in the fields next to the right limb (a, b), and a farmyard is present near the lower end of the right limb (c).

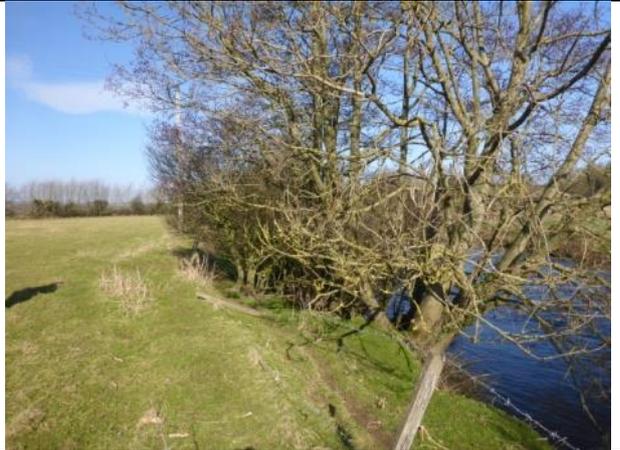
<p>a</p>

<p>9. Right hand limb riparian area</p> <p>The riparian area at the land side has barbed wire fence and is tree lined along most of the length (a). There has been some bank erosion.</p> <p>The island bank is low and suitable for flooding during high flows (b). Some of the bank area is bare but there are trees present along some of the stretch (c).</p>	<p>c</p>

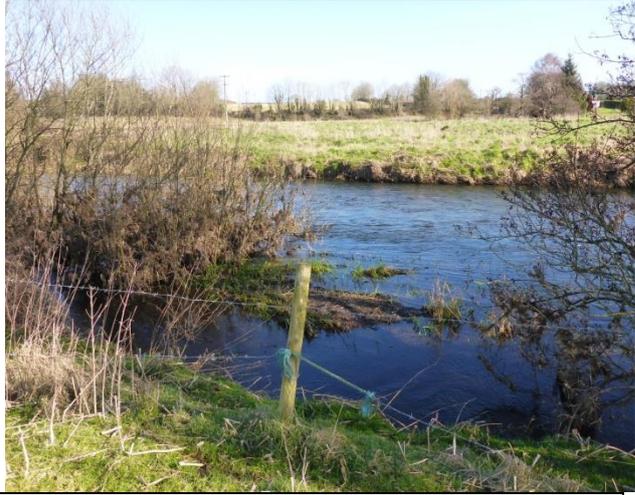
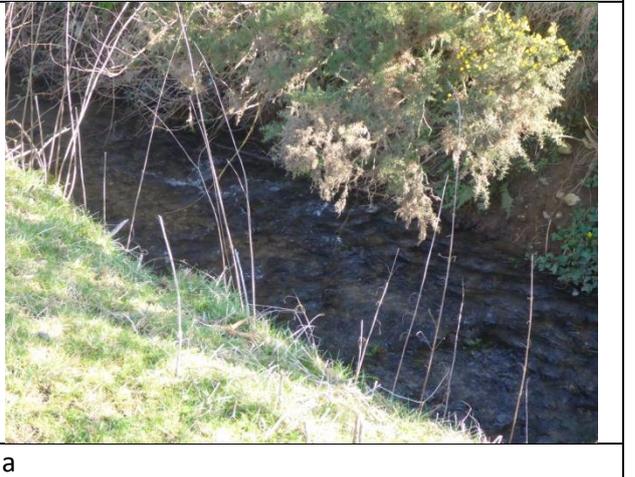
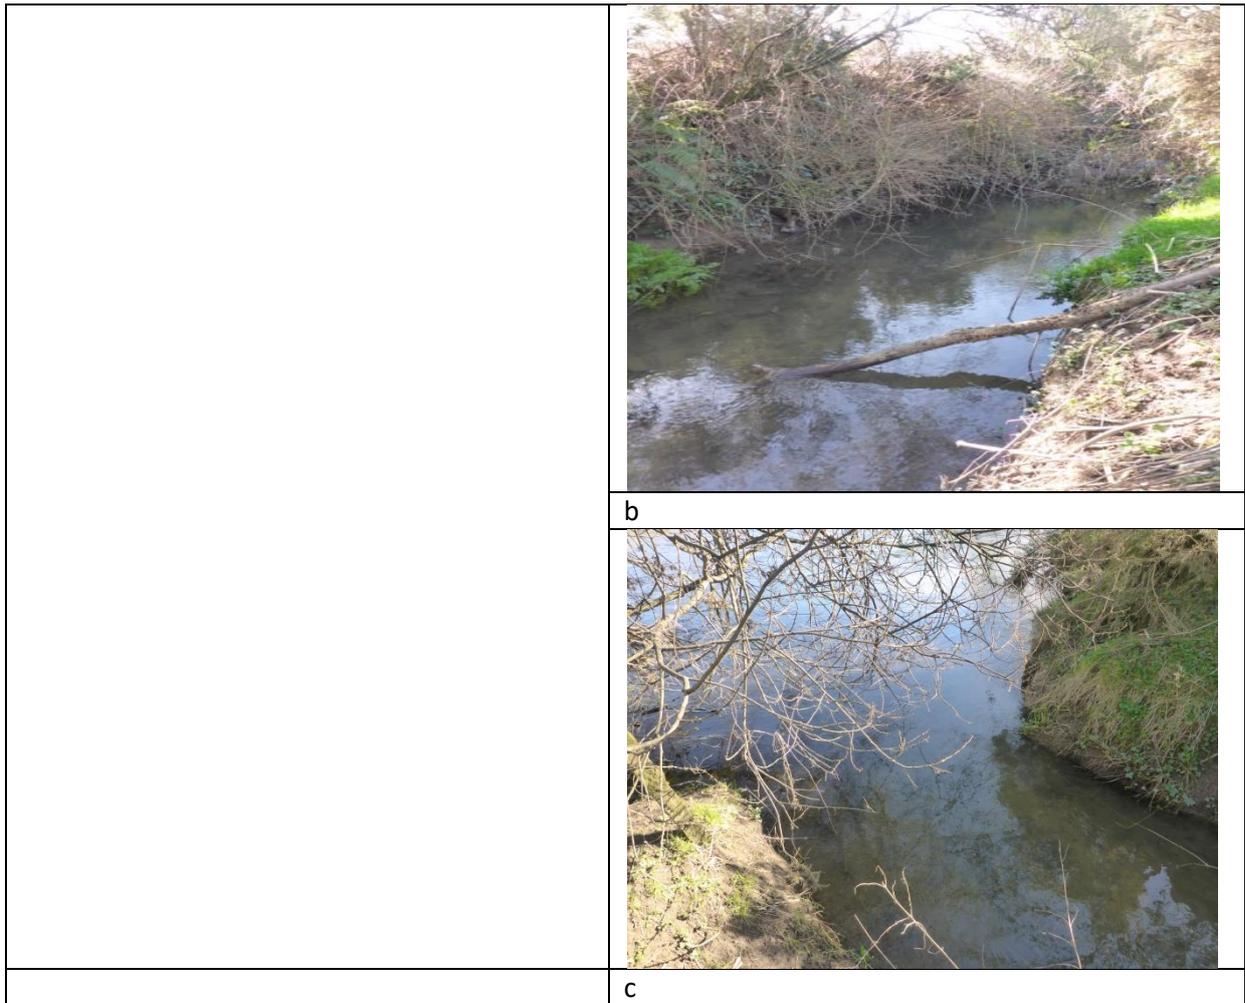
<p>10. Waterbody entering river at S 98403 44828 (a)</p> <p>The stream is rather muddy where it enters the river (b, c). The presence of clean habitat downstream of this point is unlikely.</p>
