BAT SURVEY REPORT
ENNISCORTHY FLOOD DEFENCE SCHEME
CO. WEXFORD

Prepared For Mott MacDonald

Wexford County Council

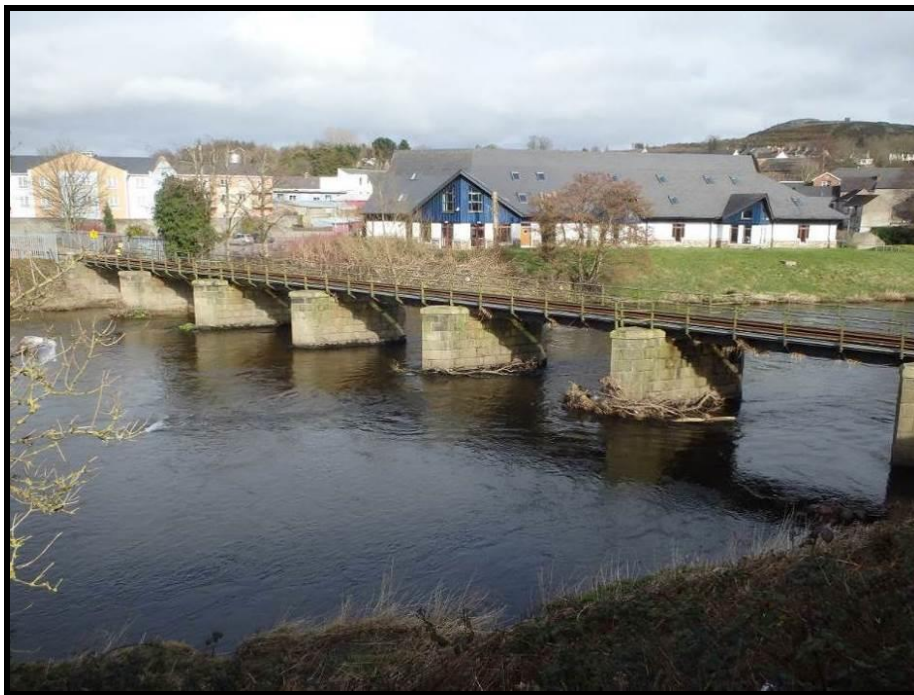
Plate 1 – Railway Bridge in the north of the Survey Area in Enniscorthy (Facing south east towards the Leisure Centre)

Structure 1 (STR01) – Railway Bridge

The railway bridge crossing the River Slaney in the north of the Survey Area was assessed for its suitability to provide roost features. The piers on this bridge are well sealed and the bridge deck is comprised of metal and wood. The structure is open to the elements and no suitable crevices etc. were noted. This bridge was categorised as '0' (no potential for bats (no suitable crevices)) on the Billington and Norman scale.

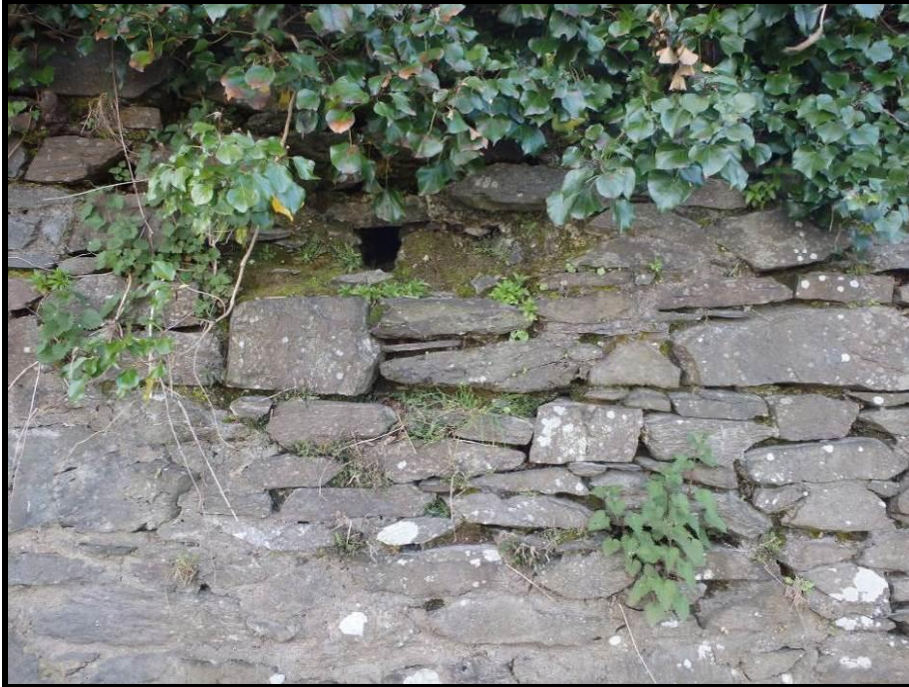
Plate 2 – Quay Walls in central and south west of the Survey Area. Note: substantial holes/crevices in walls

Structure 2 (STR02) – Quay walls

The most suitable parts of the Quay walls for roosting bats are within the section to the north east of the Old Enniscorthy Bridge. In this location, there are several substantial crevices within the old stone walls in which bats might roost. The strands of Ivy growing on the walls were noted to be thin and leafy, however

they covered crevices and voids in places within the Quay walls. The wall was classed as having 'Moderate' potential to support bats according to Table 1 in Section 4.3. Equating this evaluation to the Billington and Norman (1997) Scale for Bridge Structures, this feature would achieve a score of '2' and was considered to have crevices that were ideal for bats, but no evidence found during 2016.

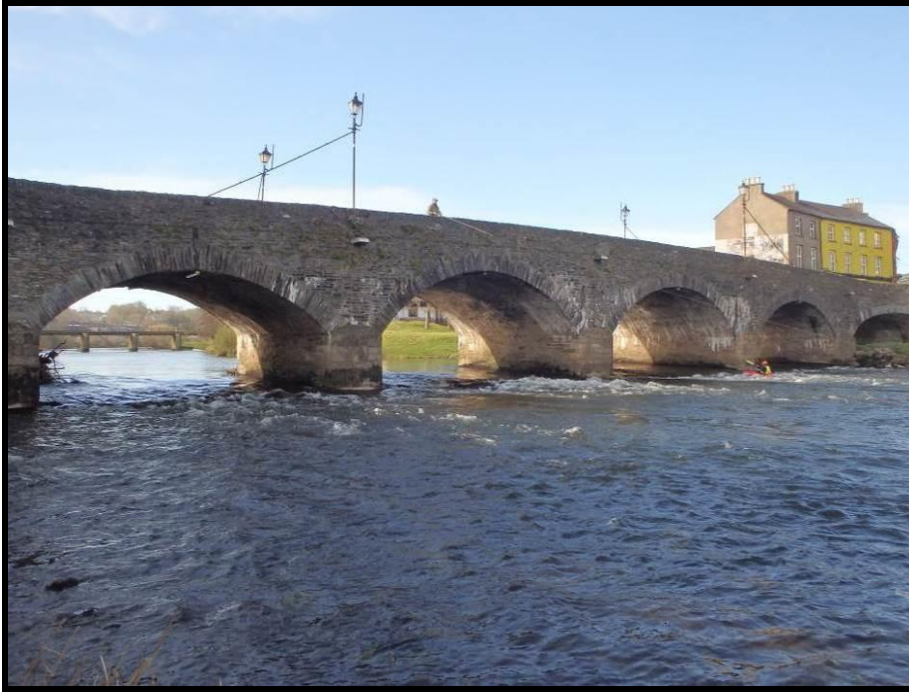
Plate 3 – The Old Enniscorthy Bridge over the River Slaney

Structure 3 (STR03) – Old Enniscorthy Bridge

This structure dates back from 1630. In 1837 the Bridge was lowered and widened⁷. It appears to have undergone maintenance over the years and does not provide suitable cracks or crevices in which bats might roost. It was classed as having a score of '0' (no potential for bats (no suitable crevices)), (Billington *et. al.*, 1997). There was no Ivy cover on this bridge.

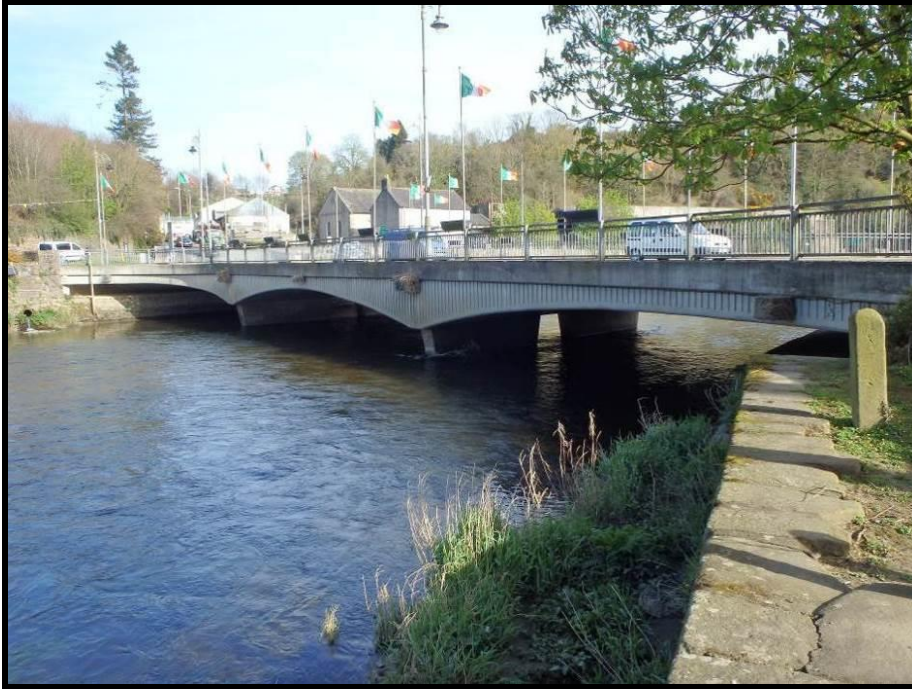
Plate 5 – The Seamus Rafter Bridge in Enniscorthy town

Structure 4 (STR04) –Seamus Rafter Bridge

This more modern bridge in Enniscorthy was opened in 1991. The cement work was well-sealed and on further inspection, it did not offer suitable cracks or crevices for bats. In addition, there was no Ivy cover. The water levels often exceed the bridge deck in high water/heavy rain. This bridge category was classed as ‘0’ (no potential for bats (no suitable crevices)), (Billington *et. al.*, 1997).

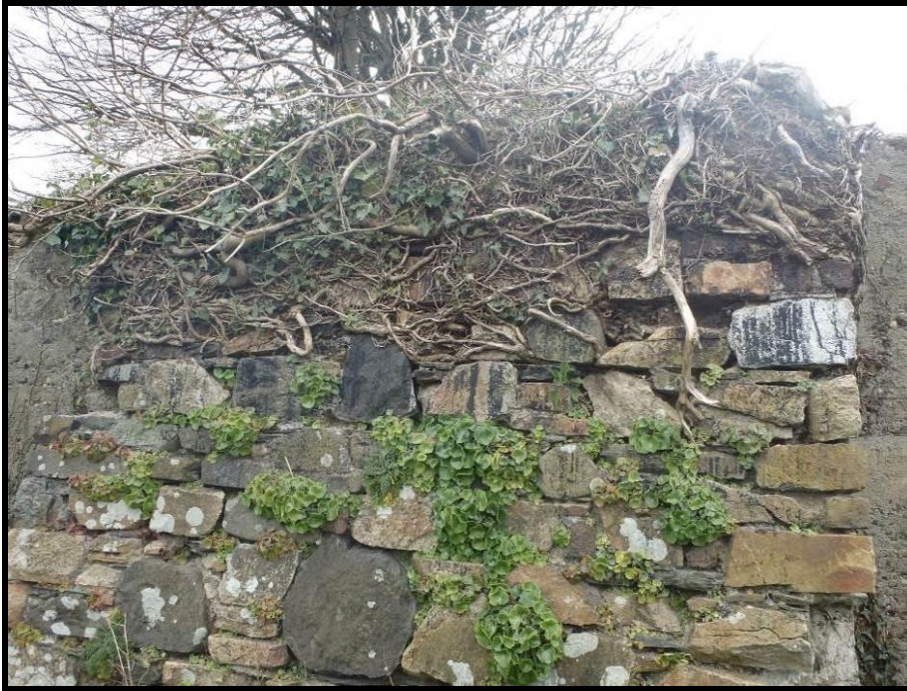
Plate 8 – The derelict building / wall on the northern floodplain

Structure 5 (STR05) - Derelict building / Old stone wall

The remnants of an old building (shown on the historic 25" maps⁸) exist on the north eastern end of the northern floodplain. This structure is in disrepair with cracks in parts of the walls where there are crevices and gaps that had the potential for use by bats. Plants growing on the wall included Ivy (thick strands), Butterfly bush *Buddleja davidii* and Navelwort *Umbilicus rupestris*. Some of the plants such as the former Ivy and Butterfly bush can offer cover for roosting bat species and the strands of Ivy on these walls were thick enough to do so. No evidence of a bat roost was recorded during the survey. This structure was considered to have 'Moderate' potential to support roosting bats (according to Table 1 in Section 4.3). Equating this evaluation to the Billington and Norman (1997) Scale for Bridge Structures, this feature would achieve a score of '1' and was considered to have crevices present that may be of use by bats, but no evidence to suggest they were currently in use.

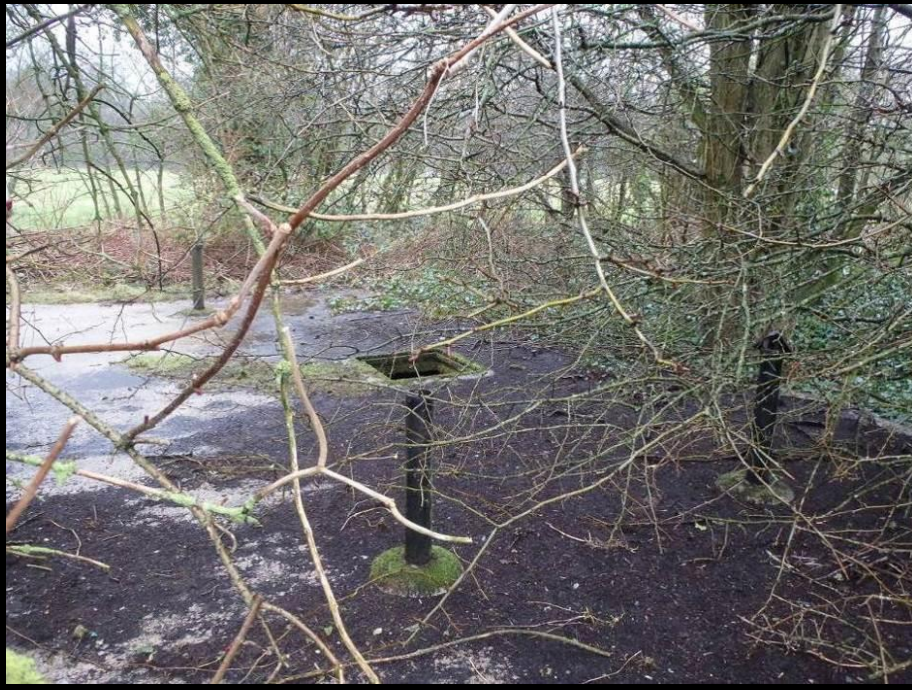
Plate 9 – Underground water tank on the northern floodplain

Structure 6 (STR06) Underground Water tank

This structure is present in the central eastern area of the northern floodplain, at approximate grid reference point S 97508 40487. It consisted of a disused underground water tank with open access holes. Visible space within the tank provided opportunities for bats to gain access and roost. However, no evidence of roosting bats were noted here during the activity surveys. The tank was considered to have 'Moderate' potential to support roosting bats (according to Table 1 in Section 4.3). Equating this evaluation to the Billington and Norman (1997) Scale for Bridge Structures, this feature would achieve a score of '2' as it provides a large enclosed space with suitable access hatches that may be of use by bats, but no evidence was recorded to suggest that bats were using this water tank during 2016.

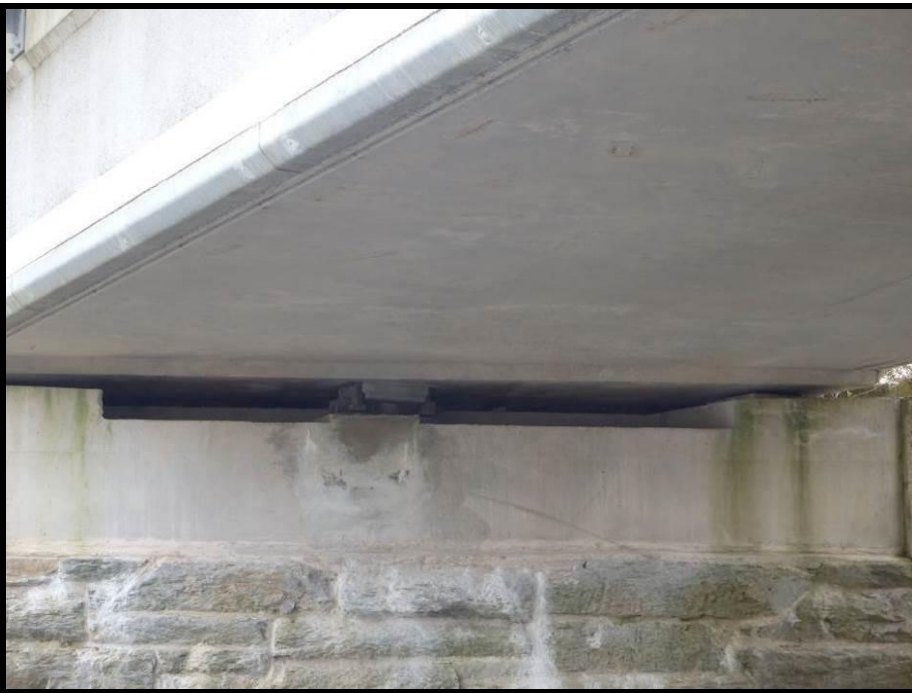
Plate 10 – Railway Bridge over the Urrin River.

Structure 7 (STR07) – Railway Bridge at Urrin River

The bridge abutment joints within this bridge offered gaps that are suitable for bats to roost within. However, no evidence of bat activity was noted here. This bridge was categorised as ‘1’ (crevices present may be of use to bats) according to Billington *et. al.* (1997).

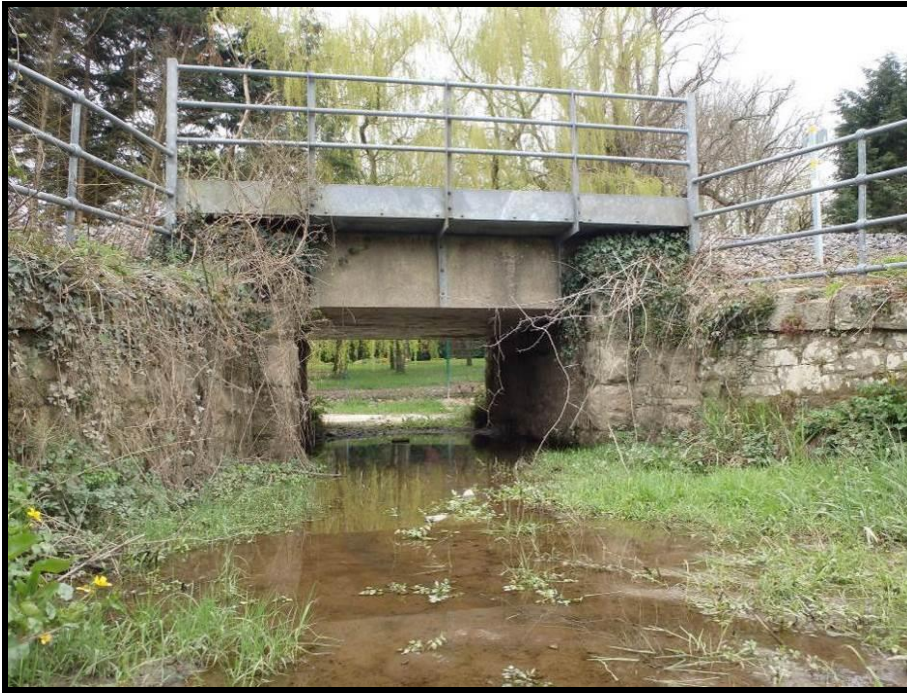
Plate 11 – Railway Bridge in south west of the Survey Area

Structure 8 (STR08) – Railway Bridge in South West of Study Area

This bridge did not offer any suitable crevices or gaps in which bats could roost. The strands of Ivy here were noted to be too thin to offer roosting opportunities. This bridge was categorised as '0' (Crevices present (may be of use to bats)) according to Billington *et. al.* (1997).

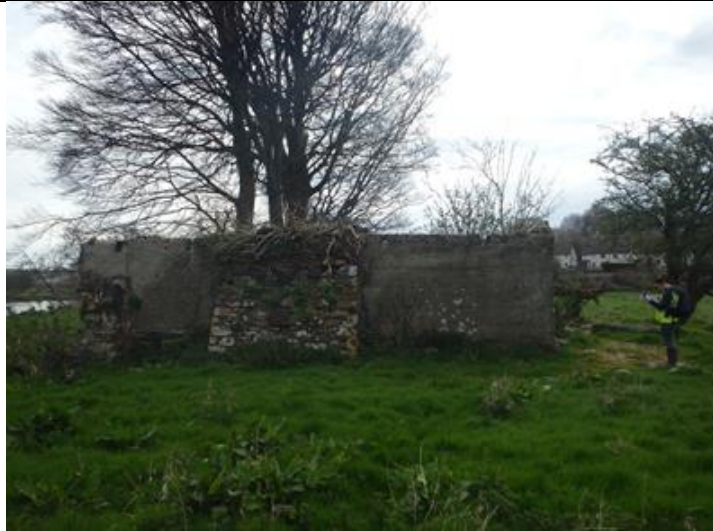
| Structure Number | Structure Name & NGR | Surrounding Habitat | Category* | Crevices | Ivy Suitable for Bats | Bat Activity Survey Results |
|---|---|---|---|---|---|---|
| STR05 | Derelict Building/walls on northern end of northern floodplain | Neutral grassland adjacent to River Slaney (not grazed in 2016) | Moderate | Cracks through walls, dense roots of Ivy / plants | No | No bats recorded roosting here in 2016, but bats recorded foraging and commuting in the area. |
